## Arborist's Report

**60 Dutton St,  
Coolangatta**

## Preliminary Arborists Report

**report no:** TPZ 25.11

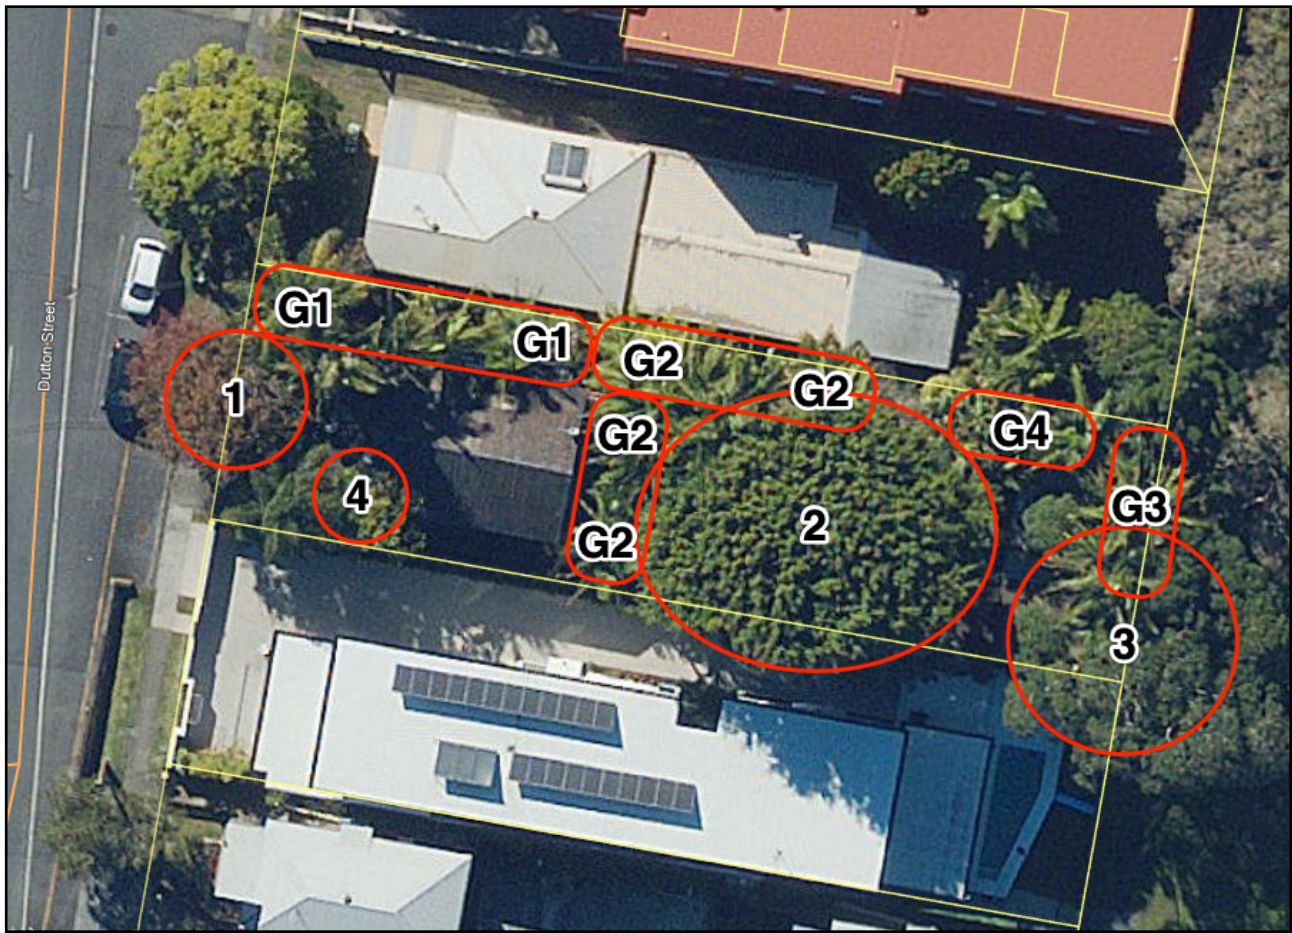
**Fig. 1:** Shows locations for the trees assessed for this report in relation to the existing site *and* proposed new shed.

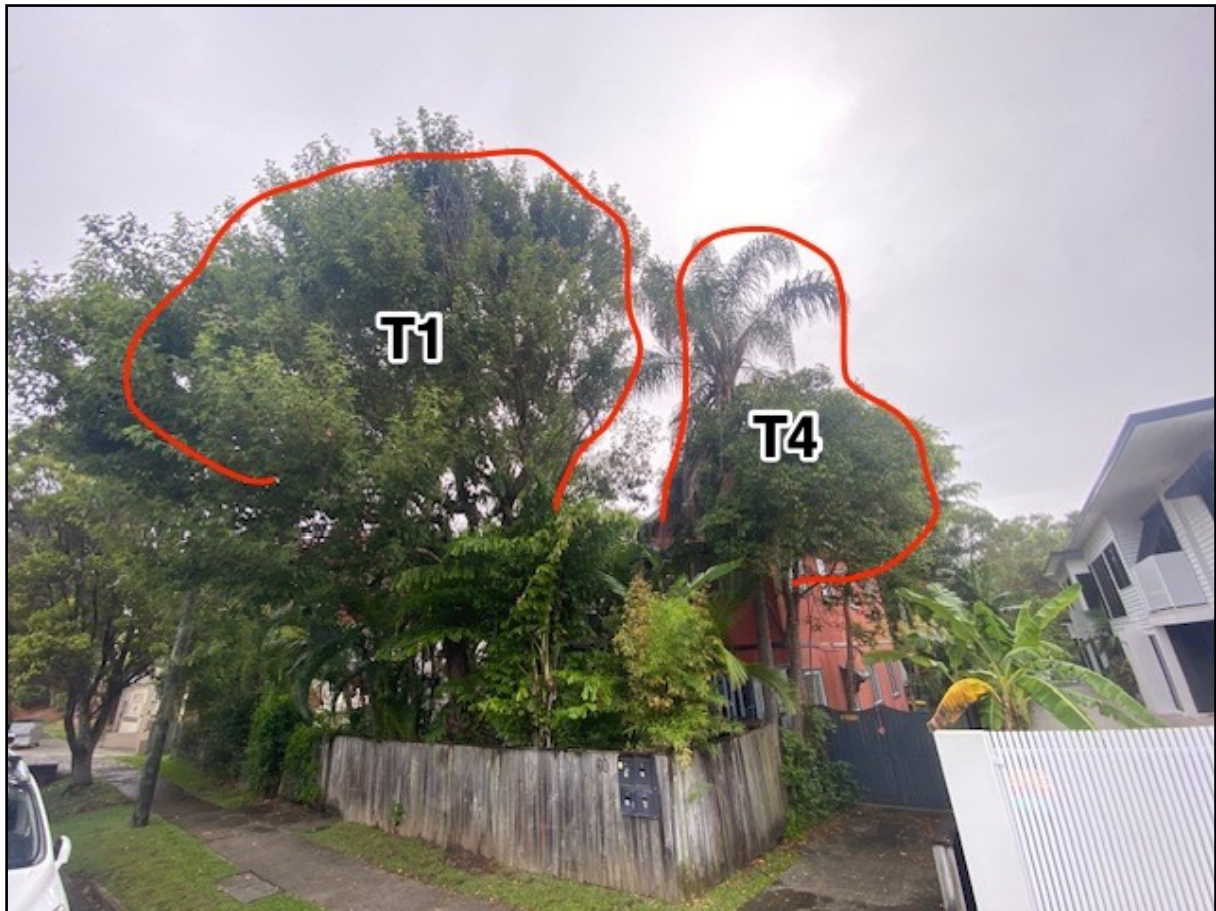
| Tree No. | Species | DBH (mm) | Height (m) | TPZ radius (m) | Vitality | Structure | Notes | Proposed |
|---|---|---|---|---|---|---|---|---|
| 1 | <i>Candlenut - Aleurites moluccanus</i> | 400 | 15 | N/A | Good | Average | <500mm from front boundary fence. As of right removal. | Remove |
| 4 | <i>Cheese Tree &amp; Cocos Palm</i> | 250 | 14 | N/A | Average | Average | As of right removal. | Remove |

**Fig. 2:** Shows a view of trees 1 and 4 from the street.

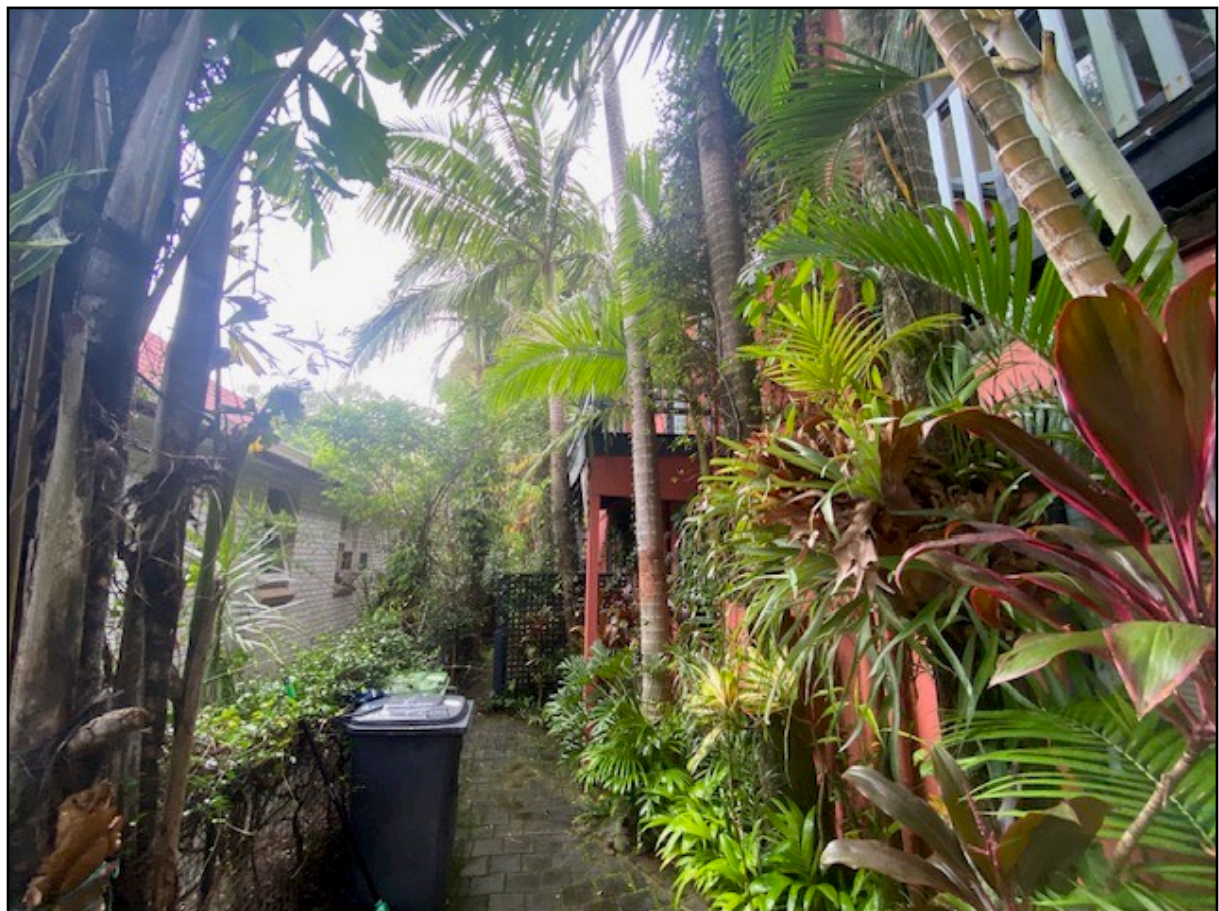
| Tree No. | Species | DBH (mm) | Height (m) | TPZ radius (m) | Vitality | Structure | Notes | Proposed |
|---|---|---|---|---|---|---|---|---|
| G1 | <i>Mixed sp. Palms x 14</i> | 200-300 | 14 | N/A | Average | Average | Coco's, Fishtail, Alexander Palms, Golden Canes. All trees in close proximity to existing house and/or boundary fence. As of right removal. | Remove |

**Fig. 3:** Shows trees in G1.

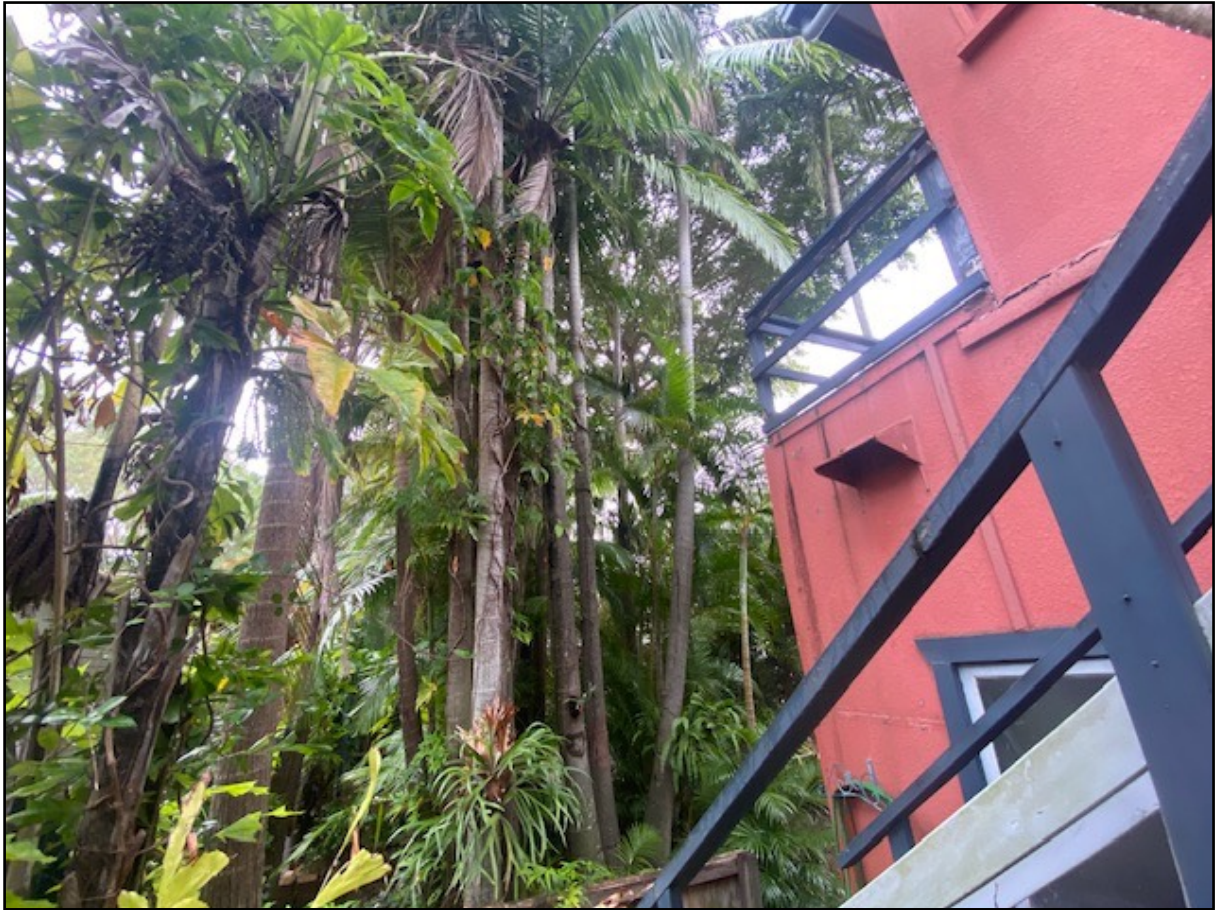
| Tree No. | Species | DBH (mm) | Height (m) | TPZ radius (m) | Vitality | Structure | Notes | Proposed |
|---|---|---|---|---|---|---|---|---|
| G2 | <i>Mixed sp. Palms x 20</i> | 300 | 16 | N/A | Average | Average | Predominantly Alexander Palms with some Golden Cane | Remove |

G2 is a very dense planting of Alexander Palms that is central to the Lot and prohibits any development outside of the existing building footprint. The trees have begun to outgrow the existing site.

**Fig. 4:** Shows dense grouping of trees in G2.

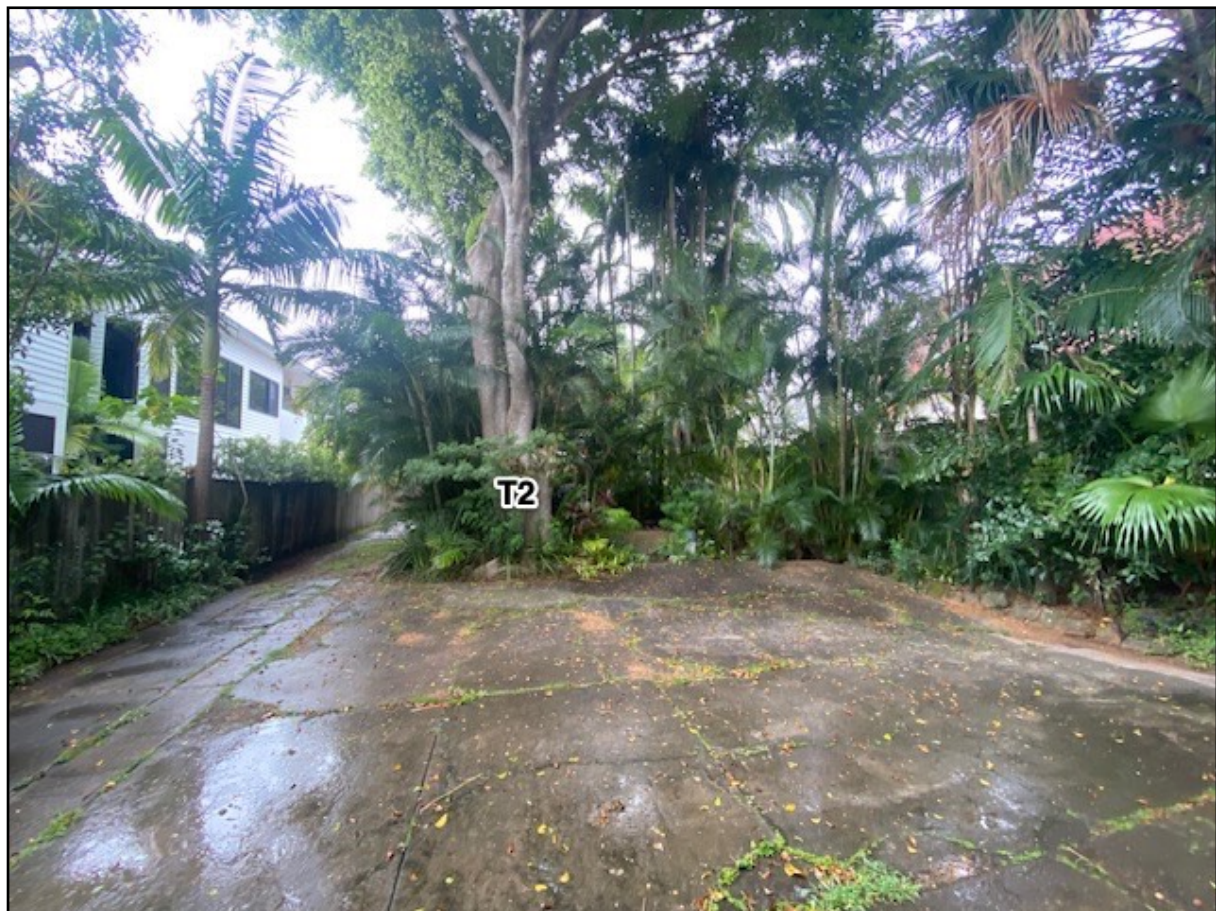
| Tree No. | Species | DBH (mm) | Height (m) | TPZ radius (m) | Vitality | Structure | Notes | Proposed |
|---|---|---|---|---|---|---|---|---|
| 2 | <i>Ficus sp.</i> | 900 | 28 | N/A | Good | Average | Codominant from approx. 2m with included bark noted at the main union. There is a large wound adjacent to the union (site of an old stem removal) where there is some active decay. The remainder of the tree has been well pruned in the past. The surrounding hard surfaces (driveway, parking etc) have been severely impacted by tree root growth. | Remove |

Tree 2 is a large, mature *Ficus* (further investigation would be required to accurately confirm the species ) which dominates the site. While large, the tree is not fully grown, and is extremely problematic in such a confined area. Existing damage to surrounding concrete surfaces is obvious, but root damage to underground services is likely both on this, and adjacent sites going forward.

**Fig. 5:** Shows location of T2 in relation to existing site and adjacent properties.

The clients early design drawings indicate a desire to utilise the whole site and, clearly for this to occur, removal of this (and all the remaining trees) is essential.

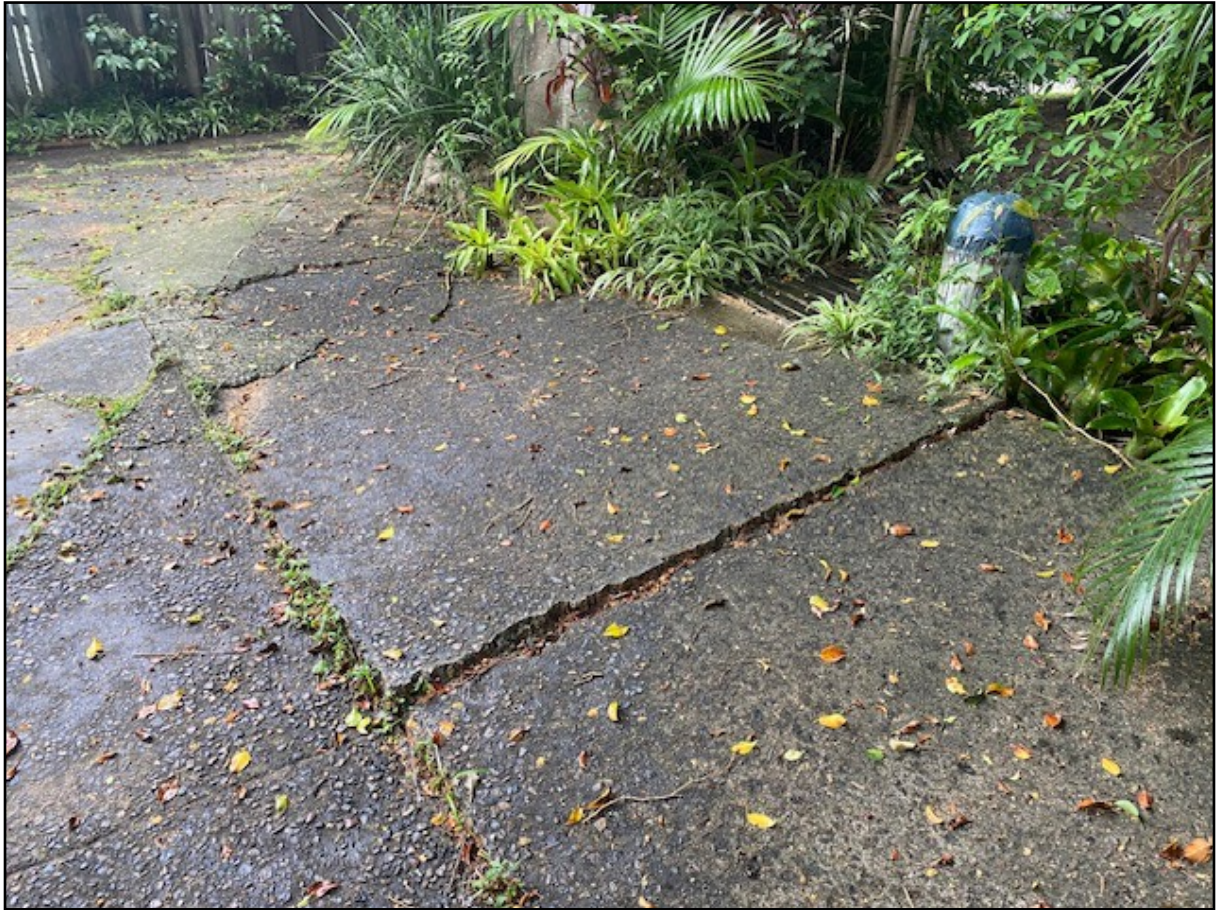
**Fig. 6:** Shows lifted/cracking concrete surfaces around T2.

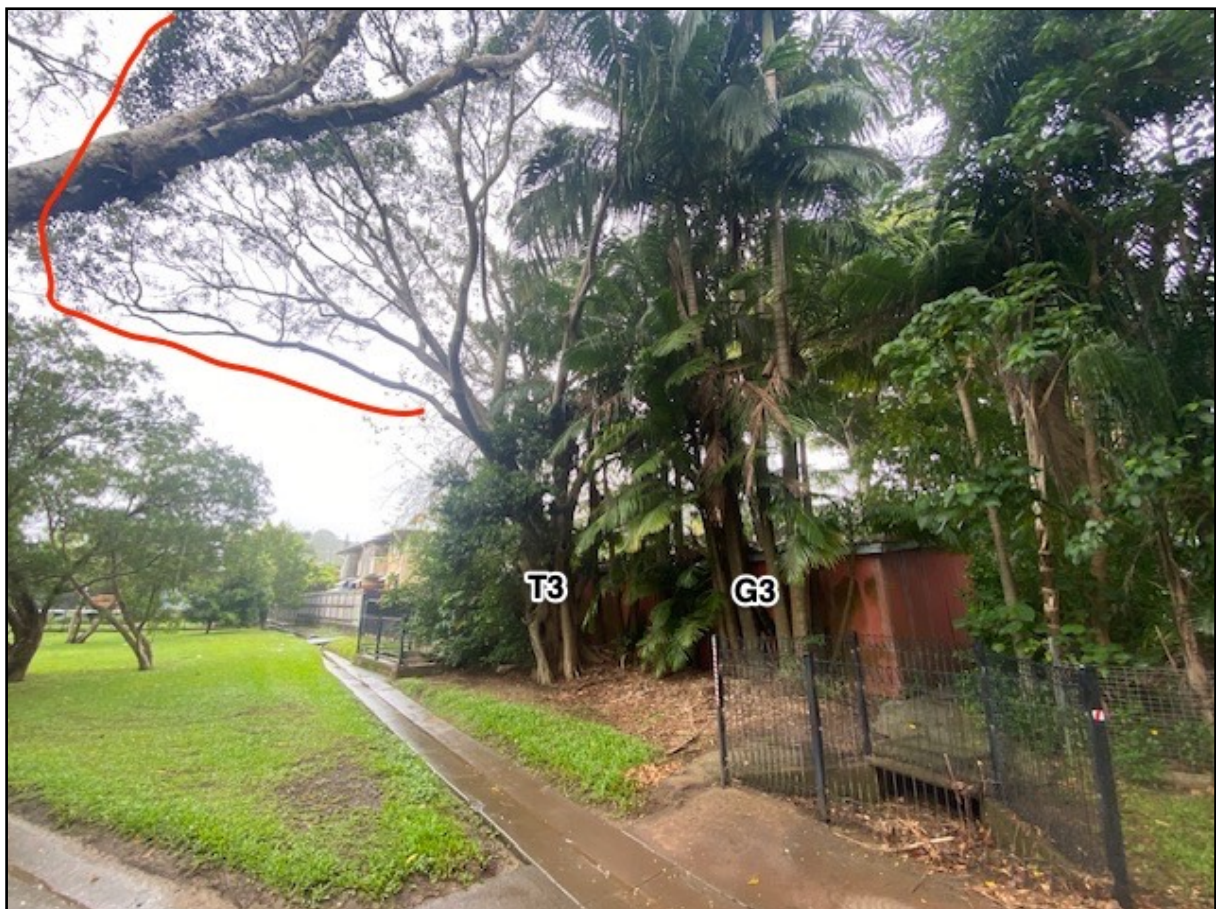
| Tree No. | Species | DBH (mm) | Height (m) | TPZ radius (m) | Vitality | Structure | Notes | Proposed |
|---|---|---|---|---|---|---|---|---|
| 3 | <i>Ficus sp.</i> | 1000 | 25 | N/A | Poor | Average | The canopy of this tree is very sparse for the species. The tree has been over-pruned in the past (although the pruning cuts are of good quality). There is some significant active decay in the main stem. The tree appears to be on the property boundary and if so, is as of right removal. | Remove |
| G3 | <i>Alexander Palms - Archontophoenix alexandrae X 6</i> | 300 x 6 | 15 | N/A | Average | Average | These trees are situated on the property boundary. As of right removal. | Remove |

**Fig. 7:** Shows T3 & G3 in-situ. Note sparse canopy of T3.
