# **ATTACHMENT 3**

## **GEOTECHNICAL CERTIFICATION**

**Project 90520.01**  
**22 January 2019**  
**L.001.DraftA**  
**GS:sj**

**Geotechnical Advice and Bulk Earthworks Global Stability Analysis**  
**Proposed Industrial Development**  
**Stapylton -Jacobs Well Road, Stapylton**

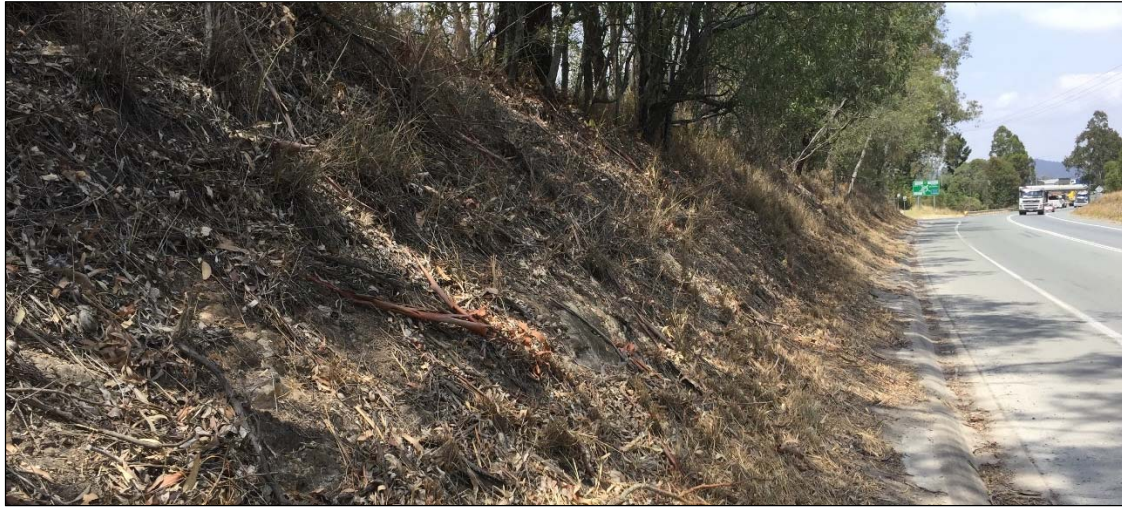
**Figure 10** Cut batter looking southwest

Based on the closest borehole information from the previous investigation and a visual inspection carried out by a senior engineering geologist from our Gold Coast office, the subsurface profile in the existing cut batter appeared to comprise residual soil over weathered metasandstone where observed. The cut varied in height from grade up to 3 m and was approximately 80 m long.

The rock mass observed was a highly weathered, low to medium strength, grey yellow orange metasandstone which was closely fractured, closely jointed, where joint planes were discontinuous, open in parts and clean.

Considering the subsurface conditions observed, the following unsupported cut batter angles are recommended for the proposed change of geometry:

- Soil and extremely low strength rock – 1V:2H; and
- Weathered metasandstone (very low strength or stronger) – 1V:0.75H

If steeper cut angles are required, the use of a retaining system such as soil nails and rock anchors mesh and structure are recommended. This method of support would require no footing and the geometry of the cut could be remodelled to near vertical. This however, would be subject to further investigation and the location of services.

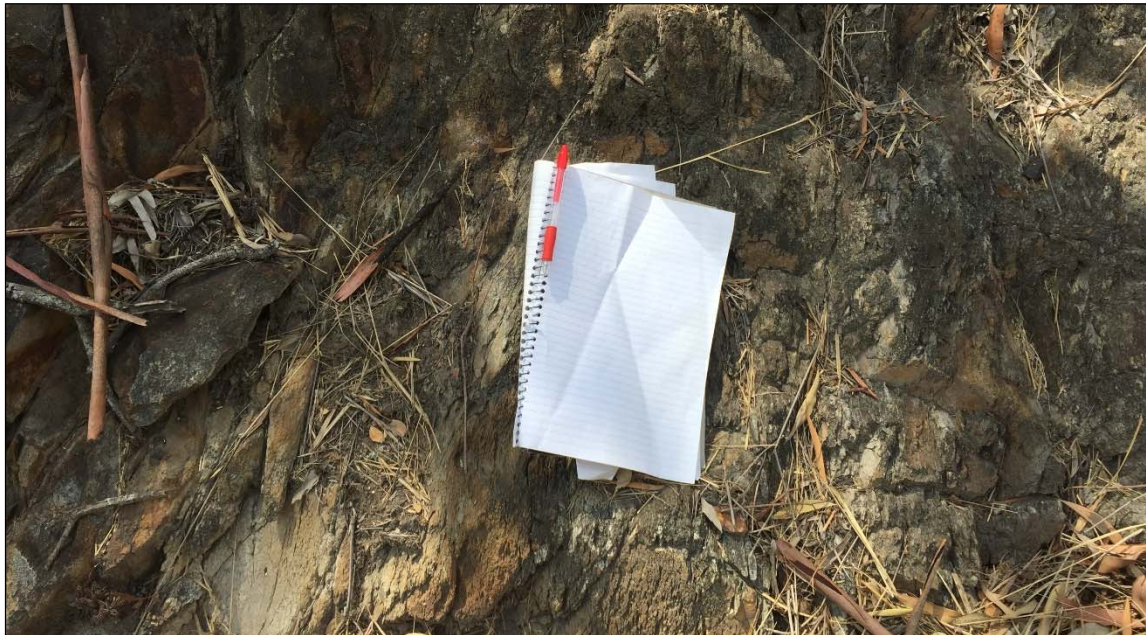
**Figure 12: Typical rock outcrop observed in the existing cut batter**

The above joint sets form a 'wedge' failure block given the orientation of the cut which 'daylights' out of the cut face. The resultant 'wedge' blocks, are typically 'soccer' ball in size.

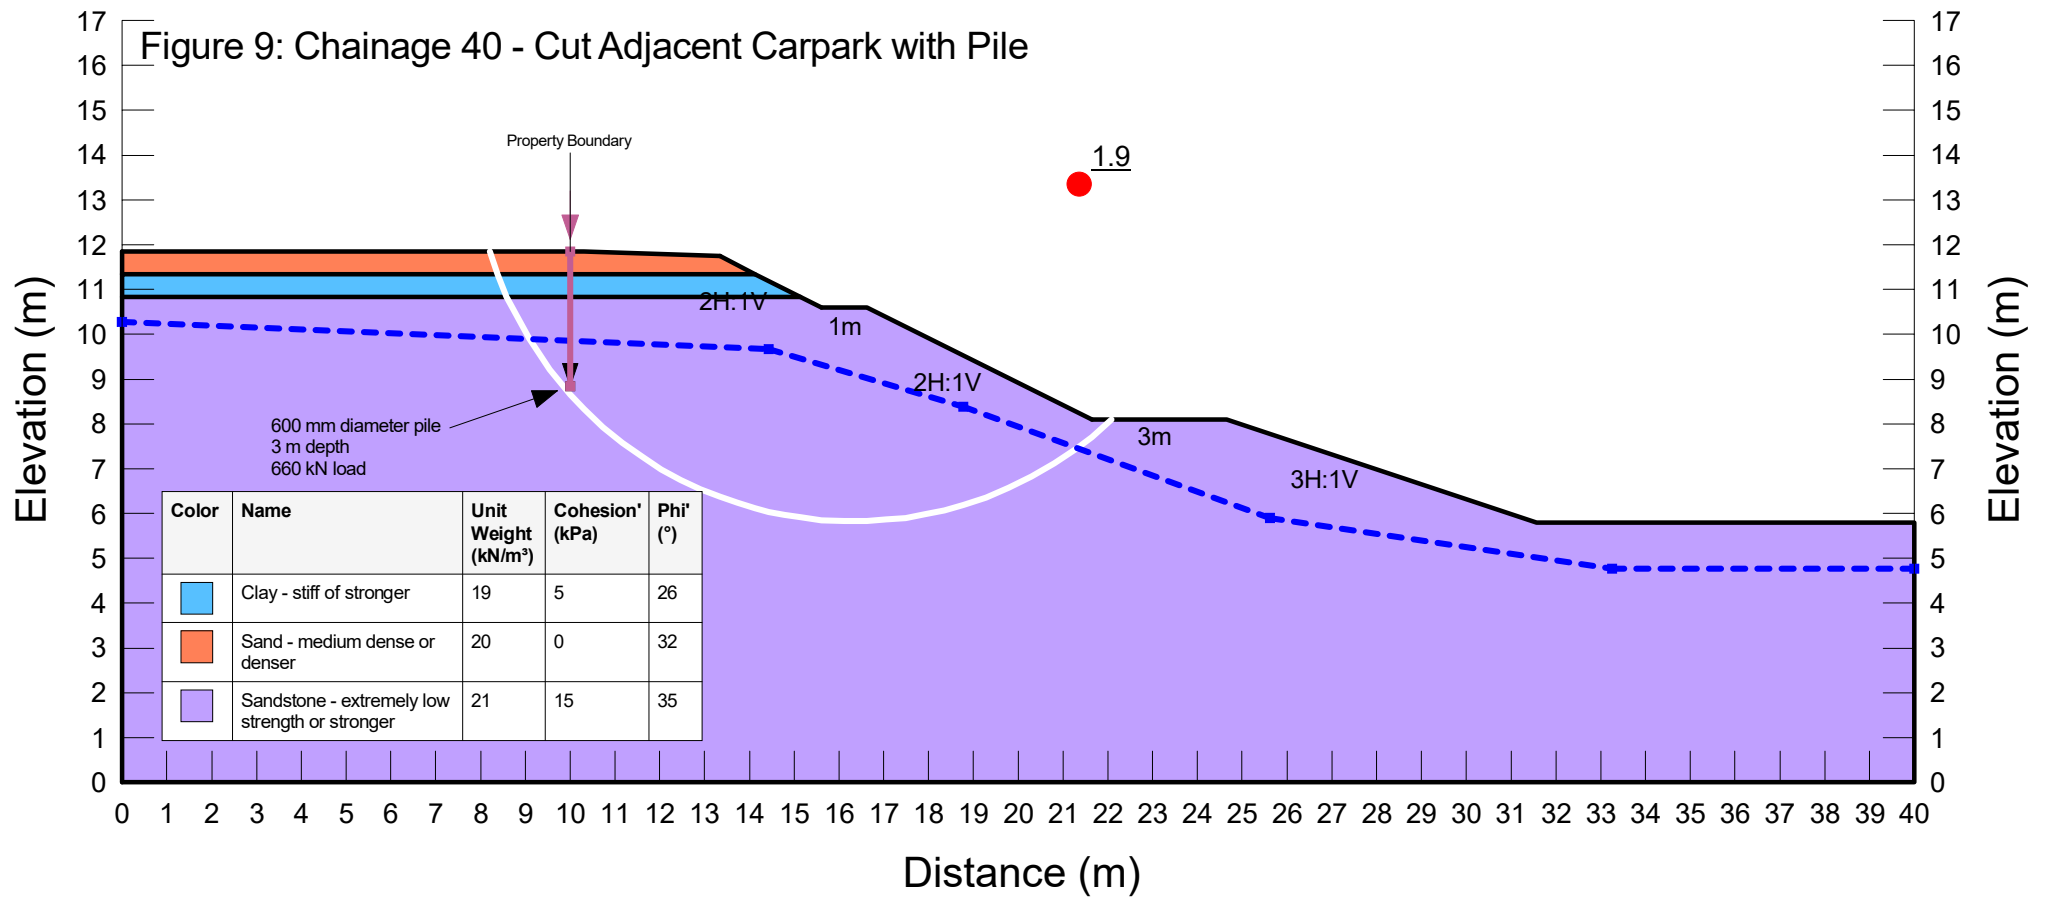
Figure 9: Chainage 40 - Cut Adjacent Carpark with Pile

| Figure | Section | Cut Batter | Factor of Safety <sup>(i)</sup> |
|---|---|---|---|
| 9 | 40 | Adjacent Existing Piles | 1.9 |

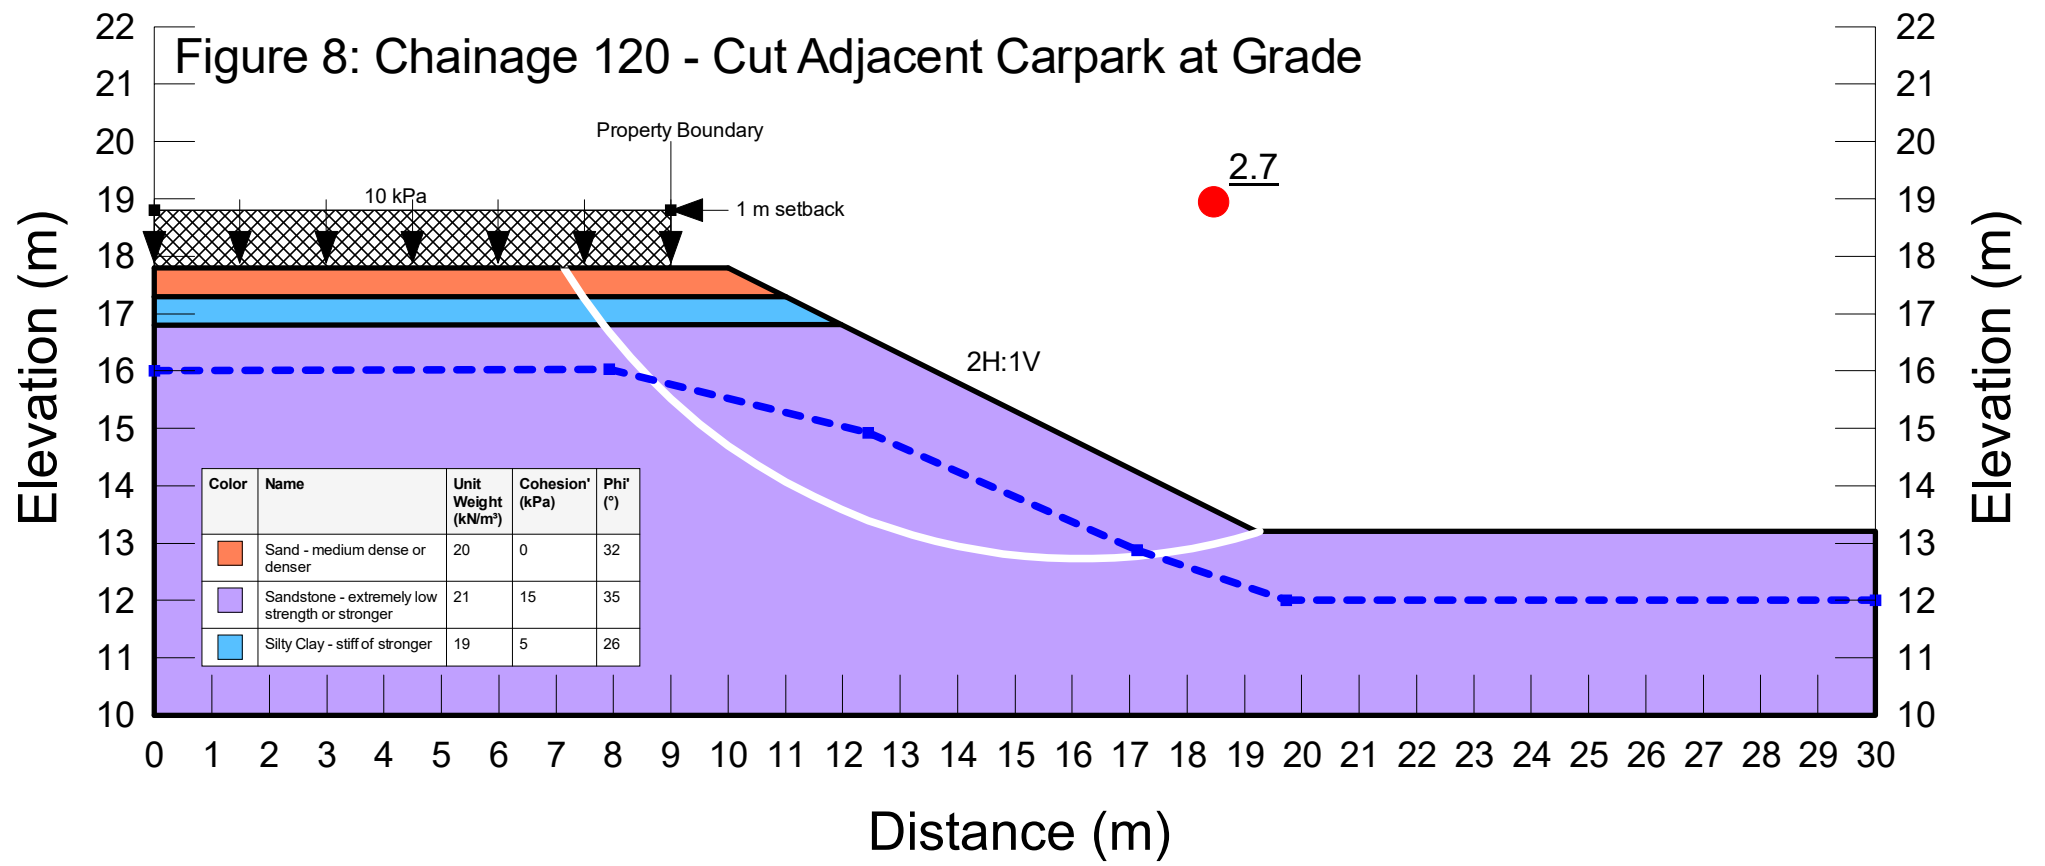
Figure 8: Chainage 120 - Cut Adjacent Carpark at Grade

| Figure | Section | Cut Batter | Factor of Safety <sup>(i)</sup> |
|---|---|---|---|
| 8 | 120 | Adjacent Carpark at Grade | 2.7 |

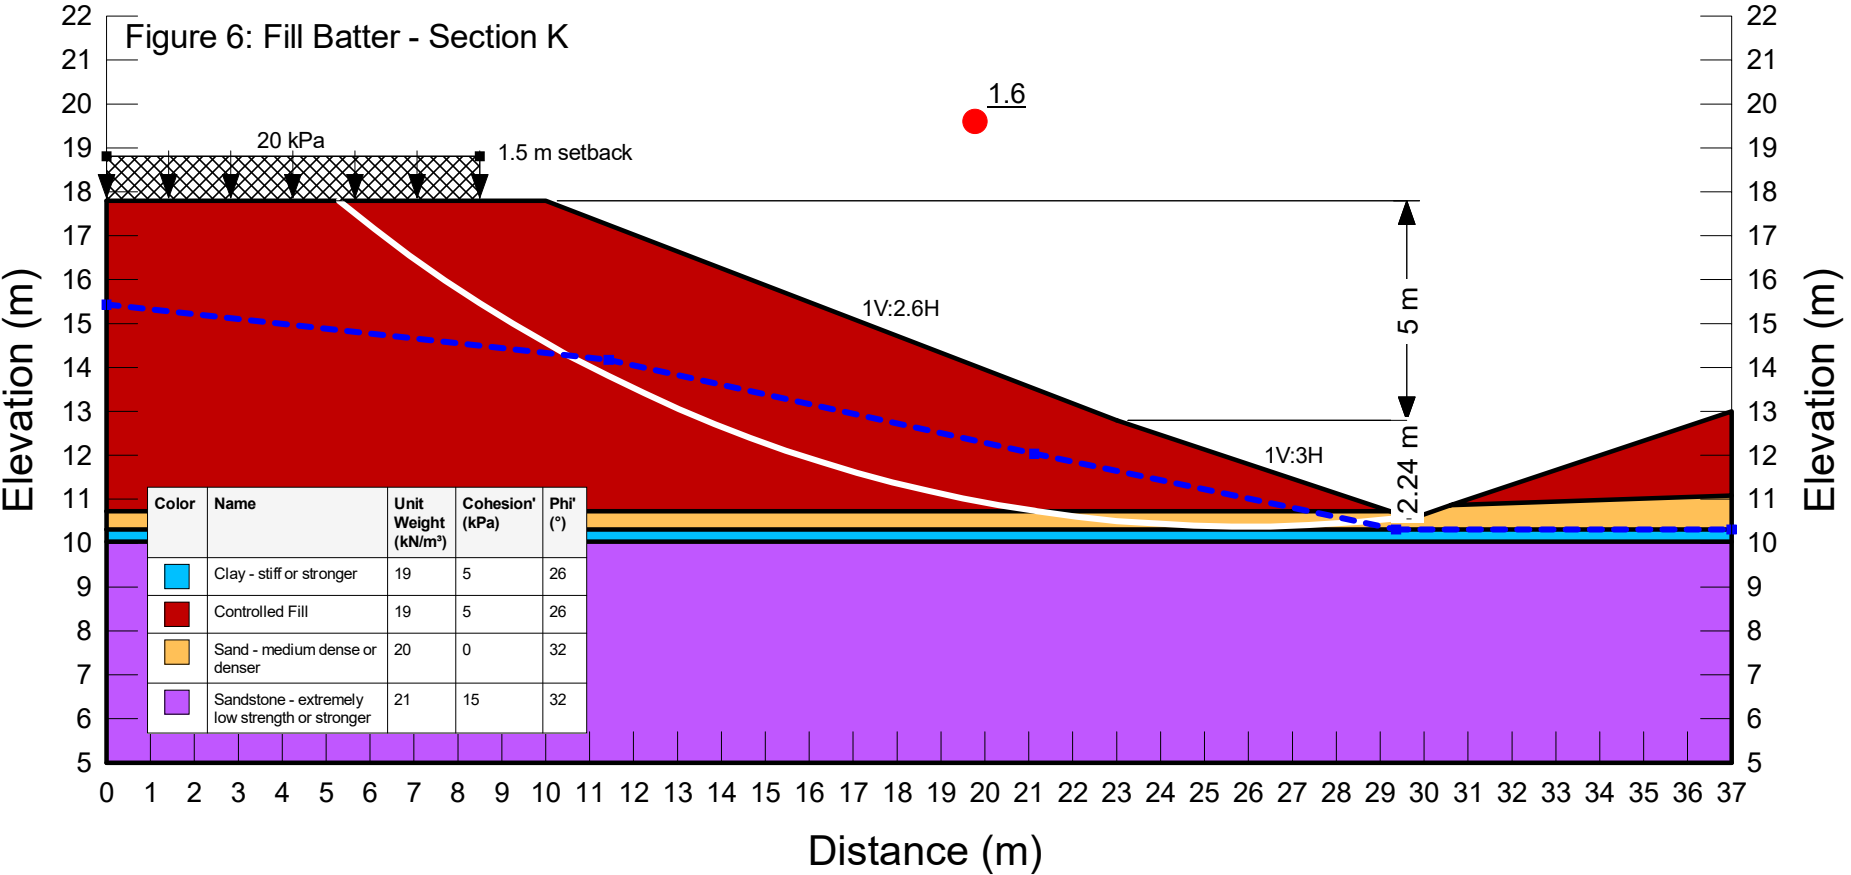
Figure 6: Fill Batter - Section K

| Figure | Section | Cut/Filling Batters/Retaining Systems | Factor of Safety <sup>(i)</sup> |
|---|---|---|---|
| 6 | K | Fill Batter | 1.6 |

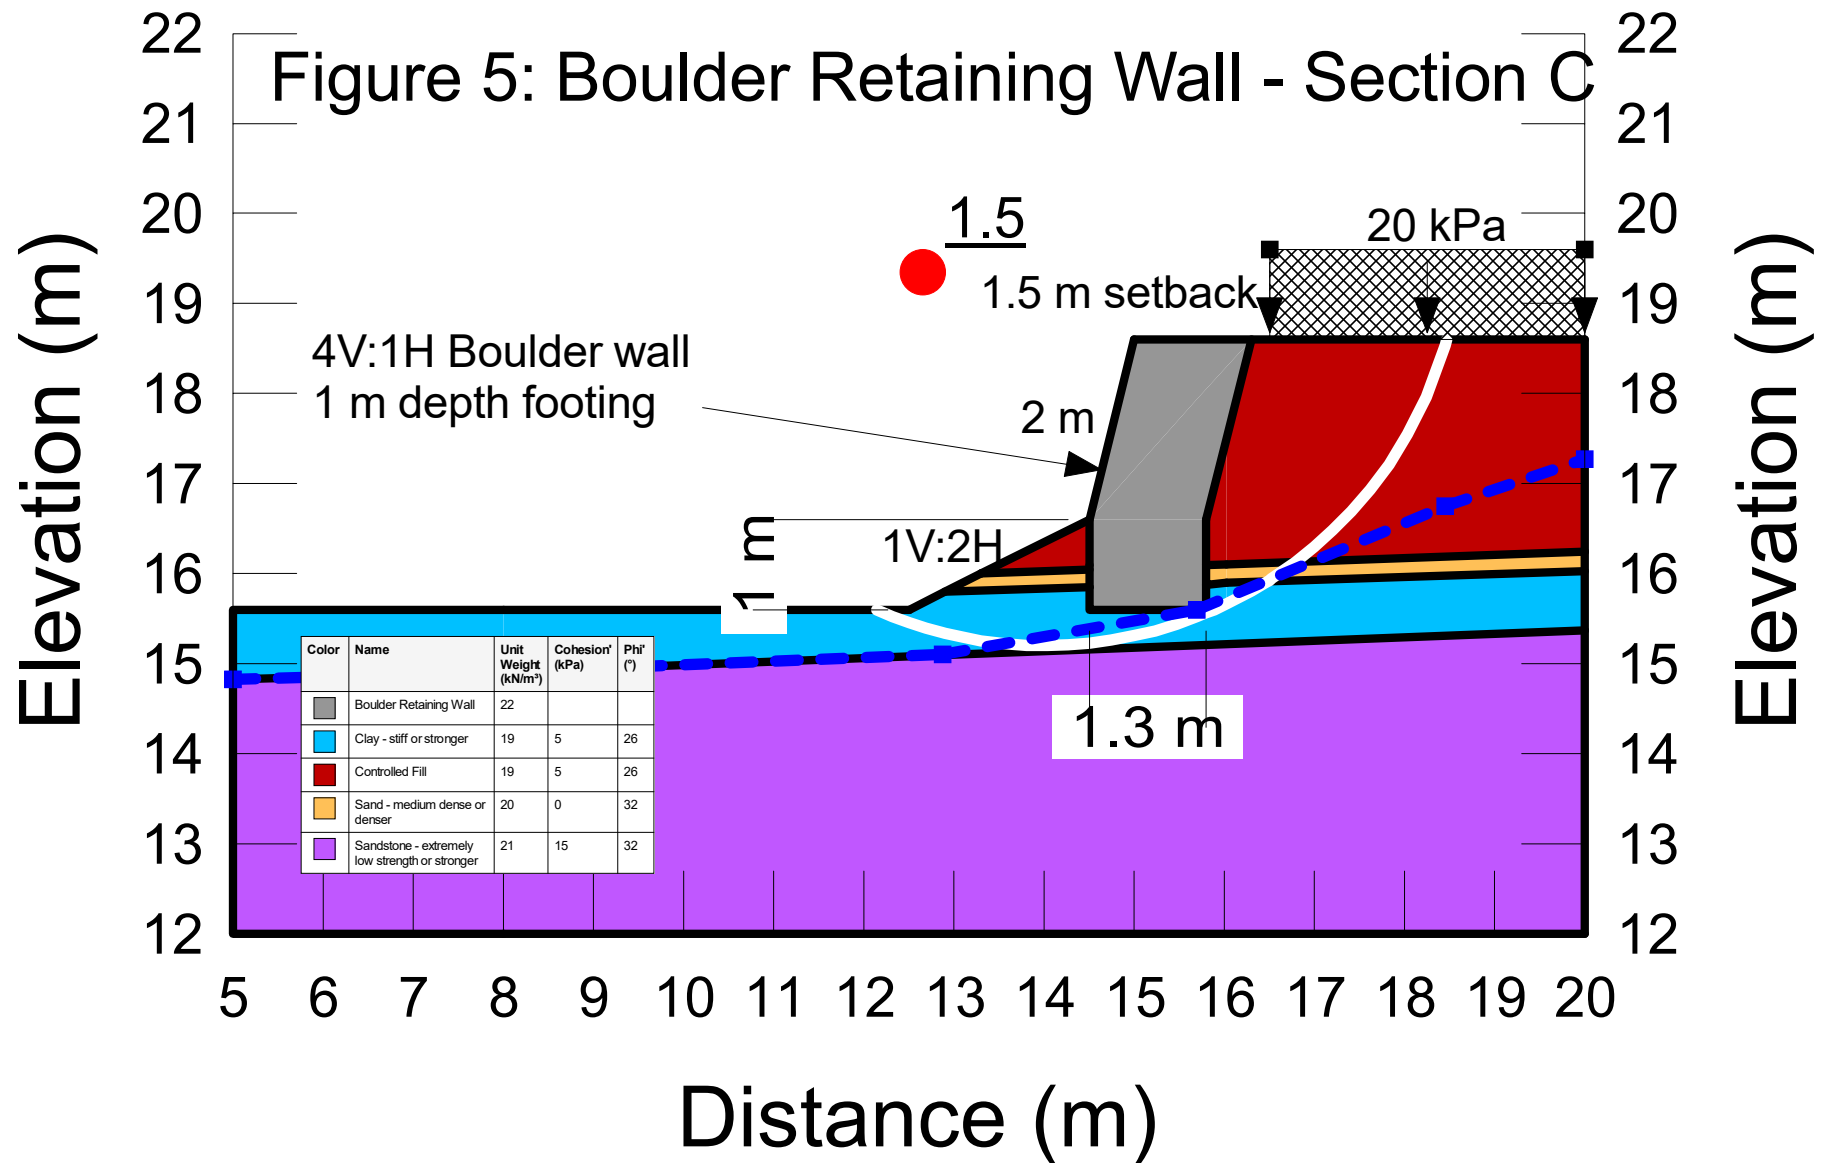
# Figure 5: Boulder Retaining Wall - Section C

| Figure | Section | Cut/Filling Batters/Retaining Systems | Factor of Safety <sup>(i)</sup> |
|---|---|---|---|
| 5 | C | Boulder Retaining Wall | 1.5 |

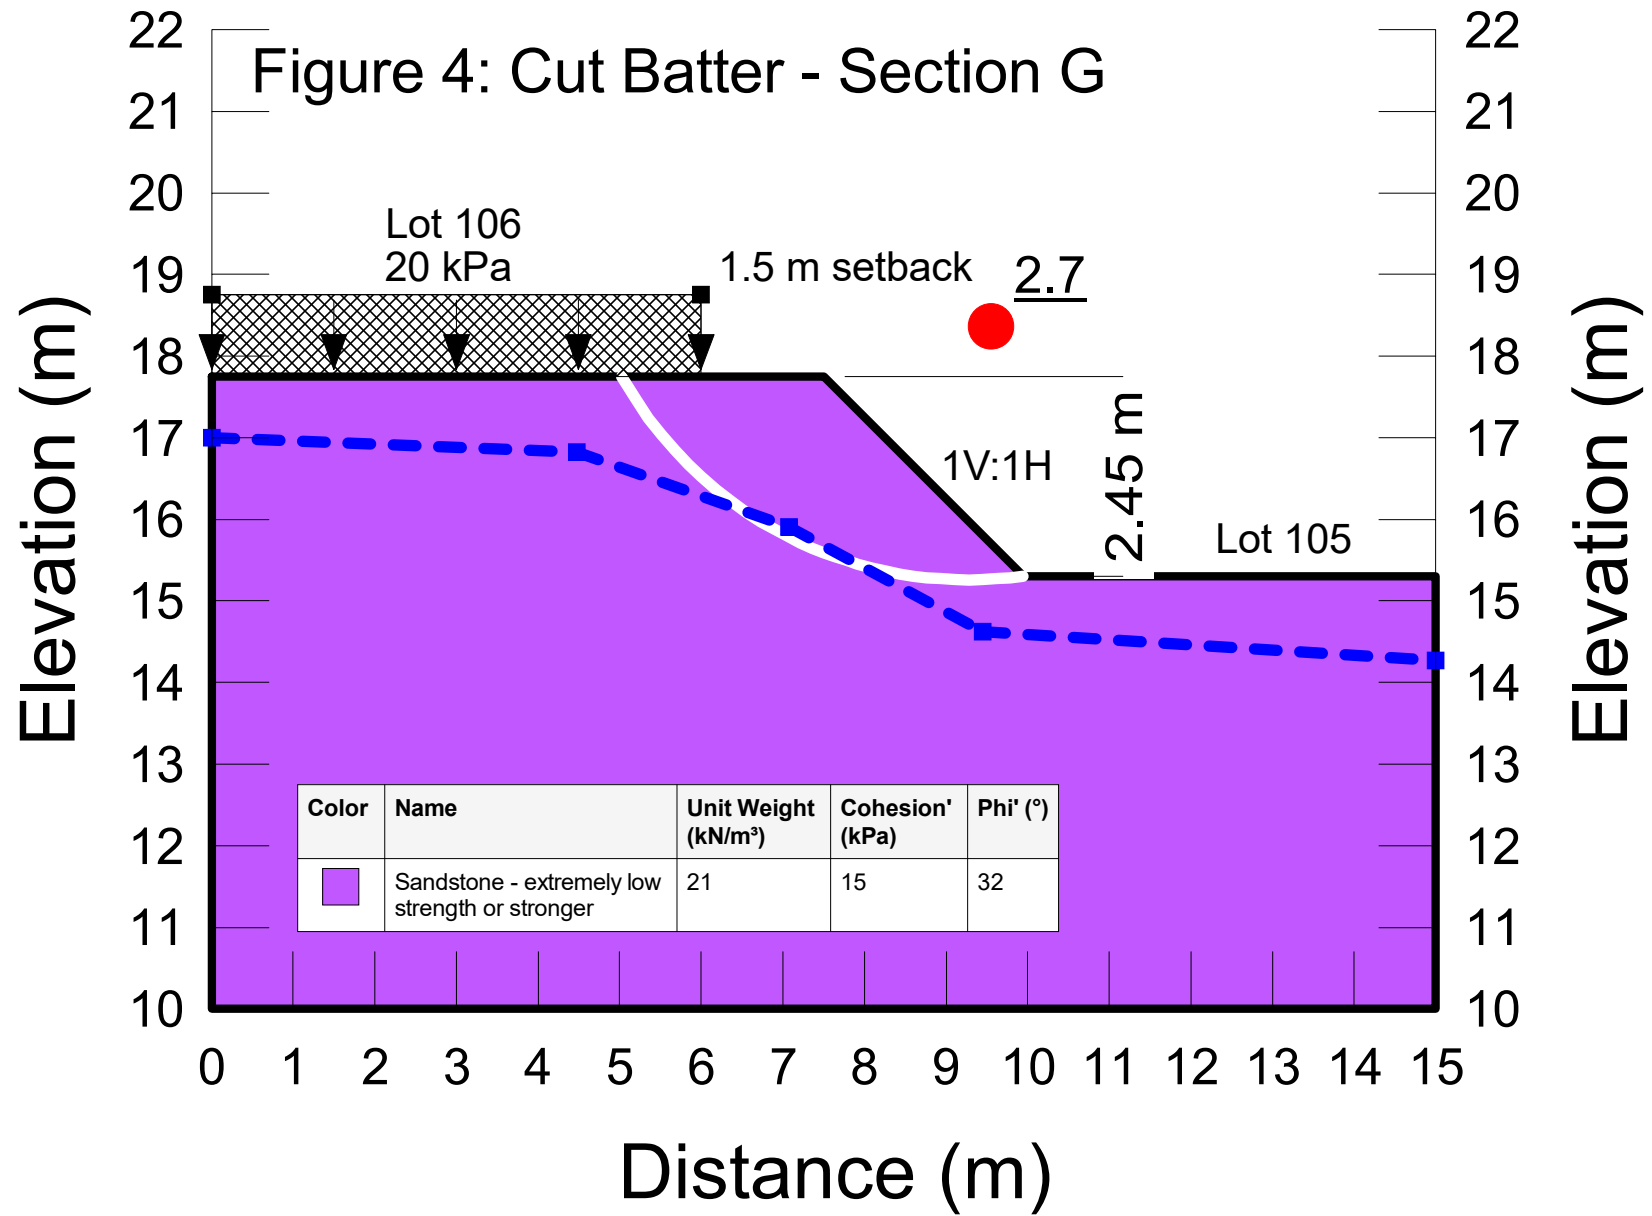
# Figure 4: Cut Batter - Section G

| Figure | Section | Cut/Filling Batters/Retaining Systems | Factor of Safety <sup>(i)</sup> |
|---|---|---|---|
| 4 | G | Cut Batter | 2.7 |

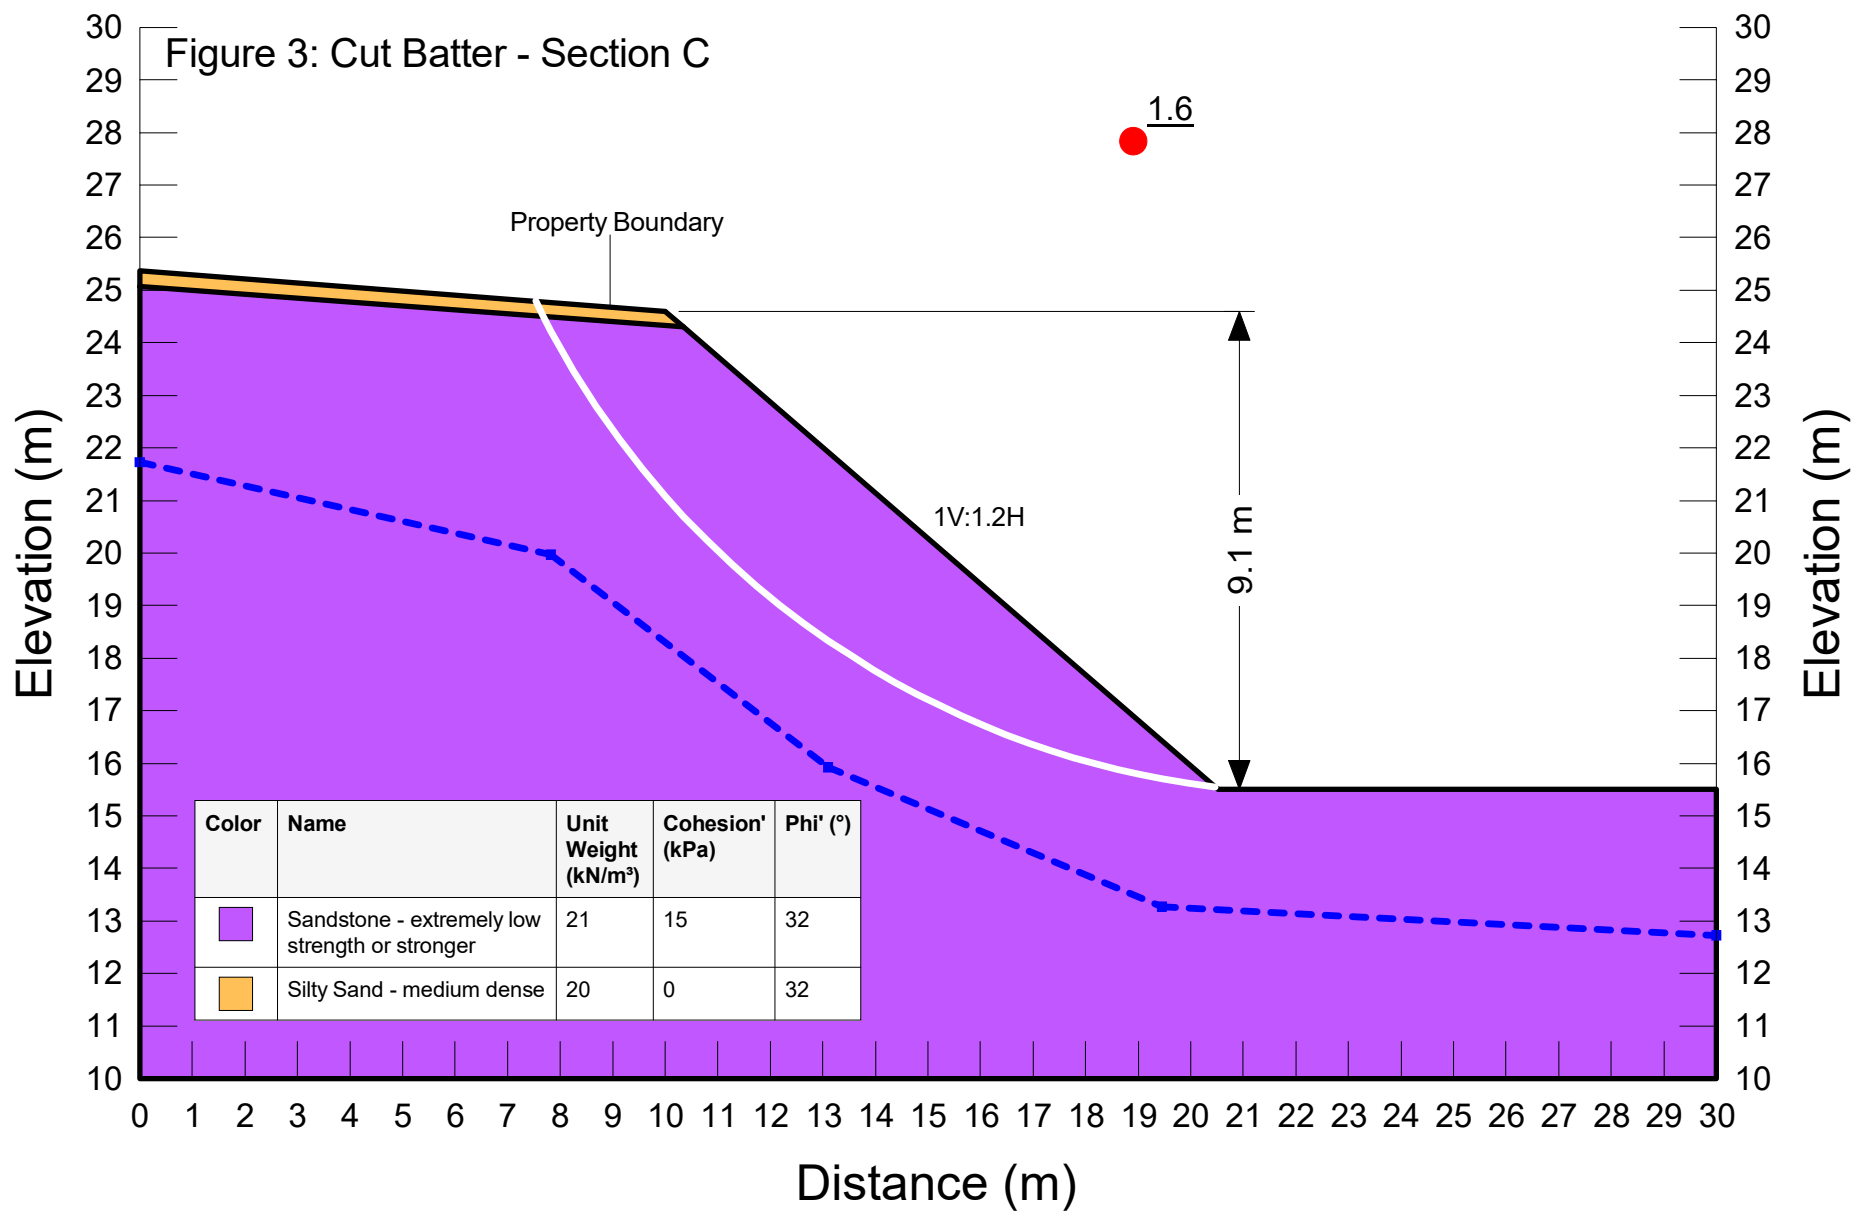
Figure 3: Cut Batter - Section C

| Figure | Section | Cut/Filling Batters/Retaining Systems | Factor of Safety <sup>(i)</sup> |
|---|---|---|---|
| 3 | C | Cut Batter | 1.6 |

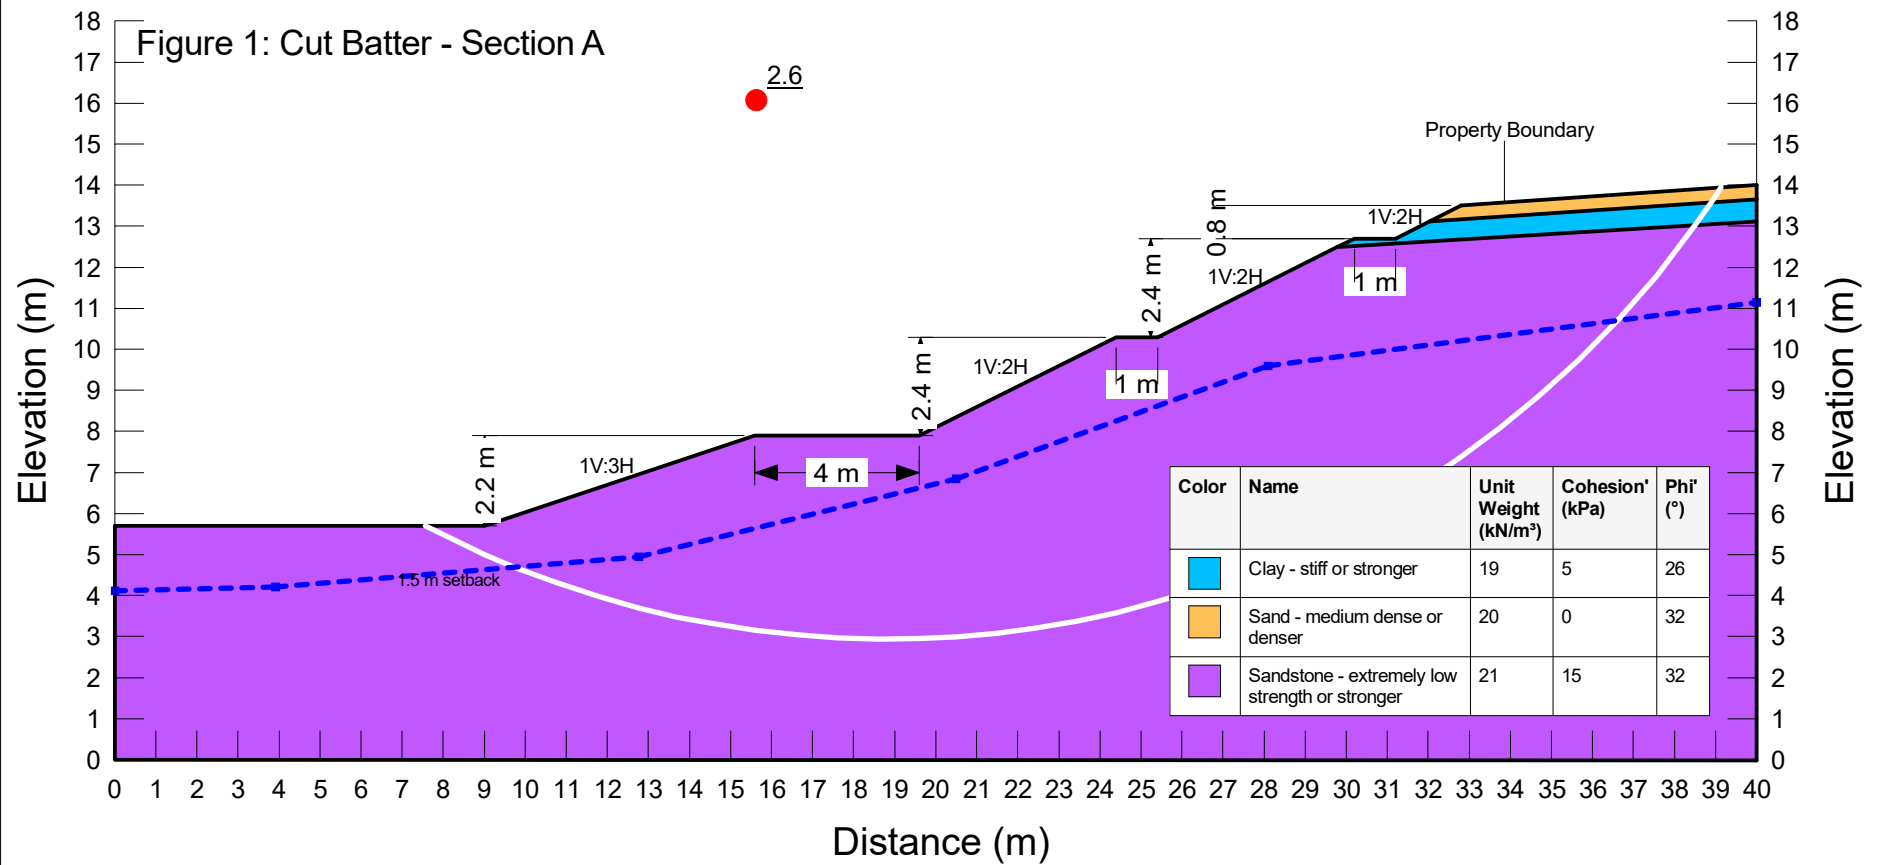
Figure 1: Cut Batter - Section A

| Figure | Section | Cut/Filling Batters/Retaining Systems | Factor of Safety <sup>(i)</sup> |
|---|---|---|---|
| 1 | A | Cut Batter | 2.6 |
