Job Name: Woolworths Liquor Stapylton

**DATE:** 19 July 2023

**REFERENCE:** J001906-011-TM-Rev0

**BATTER SLOPE SHOTCRETE DESIGN  
WOOLWORTHS WAREHOUSE, STAPYLTON JACOBS WELL RD, STAPYLTON**

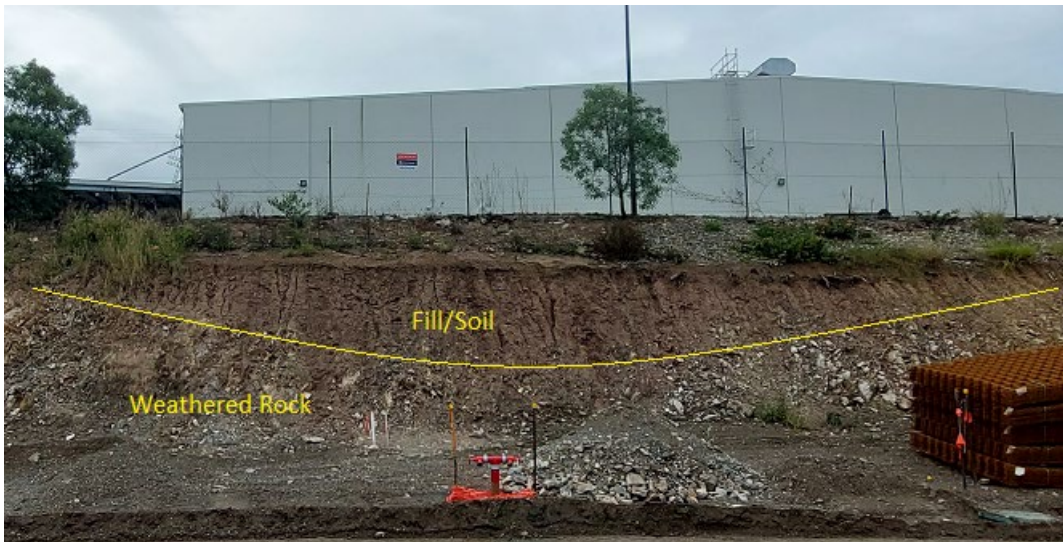
As requested by McNab, a senior geotechnical engineer from Core Consultants Pty Ltd (Core) carried out a site visit on 18 July 2023 to inspect a section of the northern batter that requires soil nail and shotcrete treatment. The section of interest is shown below in Image 1 and comprises a zone of soil and fill about 30 m in length contained in a depression in the underlying rock. The slope face is about 6 m in height and formed at a slope of about 1V:1H apart from an upper section about 1 m high in soil formed at 1V:2H which will remain.

**Image 1: Northern batter area requiring treatment**

Previous investigation by others and inspection of the batter indicates that the fill/soil zone comprises a very stiff silty clay to a maximum of about 4 m below the adjacent surface, whilst the weathered rock comprises a low to high strength fractured arenite.

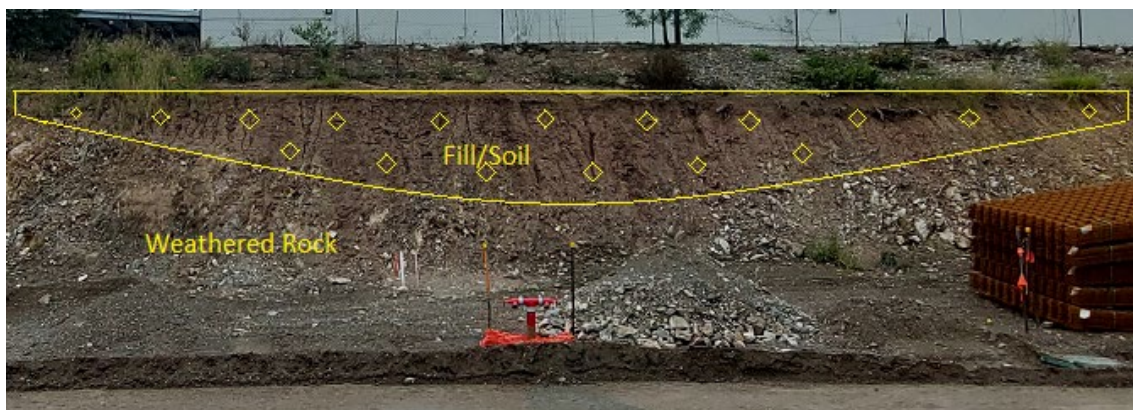
**Image 2: Indicative proposed Soil Nail layout**

A single row of soil nails at 2.5 m centres was adopted along the top of the wall with a second row of six nails (stagger pattern) where the shotcrete height exceeded about 1.5 m (refer Image 2). The nails were adopted as:

- 3 m in length and fully grouted in a 150 mm diameter holes with a declination of 20°
- N28 bar with a yield stress of 500 MPa and factored yield capacity of 270 kN
- working bond stress of 30 kPa in soil and fill and 50 kPa in mixed soil/weathered rock

- Holes to be air drilled and flushed to remove loose debris
- All loose materials to be removed from face
- Bars to comprise N28 galvanised bar sheathed for corrosion protection with centralisers and fixed to shotcrete with 300 mm cog over the mesh or 200mm square galvanised plate and nut
- 32MPa grout installed using sacrificial grout tube within 24 hours of drilling
- Weep holes (16 No.) placed intermediate to soil nail positions
- Shotcrete facing to be 32 MPa (28 days) minimum 125 mm thick but not exceeding 250 mm with SL92 galvanised mesh and keyed into weathered rock at the shotcrete facing base and formed at top of shotcrete crest to prevent water infiltration from upslope

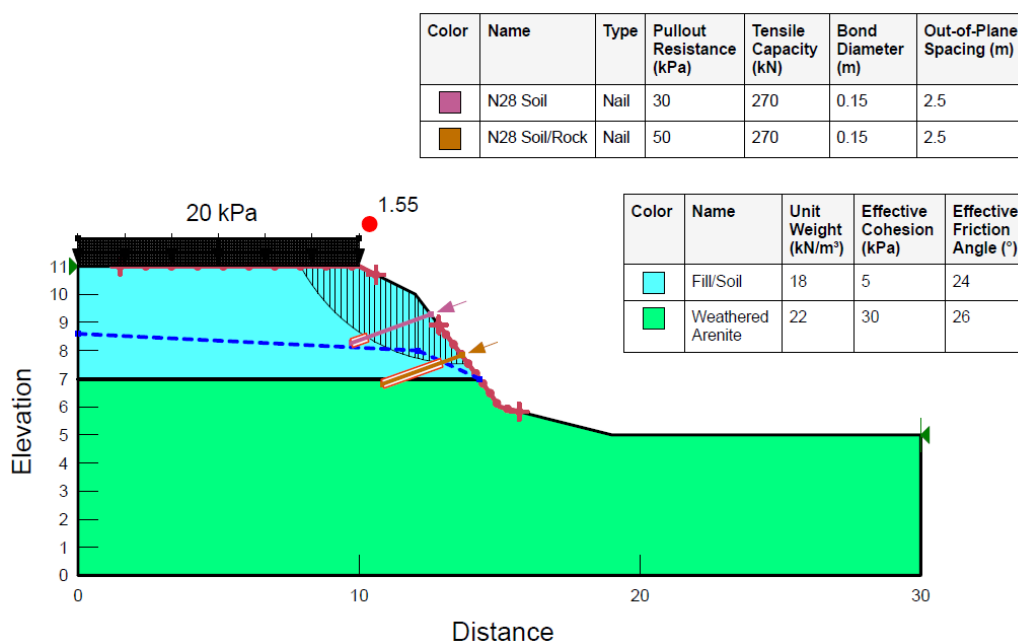
Stability analysis of the slope and proposed shotcrete and soil nail was undertaken using SlopeW with soil parameters assessed from experience; those values are shown on the stability output in Image 3.

The results of the stability analysis are shown below in Image 3 and indicate that the proposed works achieve a safety factor exceeding the minimum of 1.5 required for permanent works.

**Image 3: Results of SlopeW Analysis**
