# Arboricultural Impact Assessment & Tree Protection Plan

27 August 2026

25 & 27 Vista Street & 2959 Surfers Paradise Boulevard Surfers Paradise

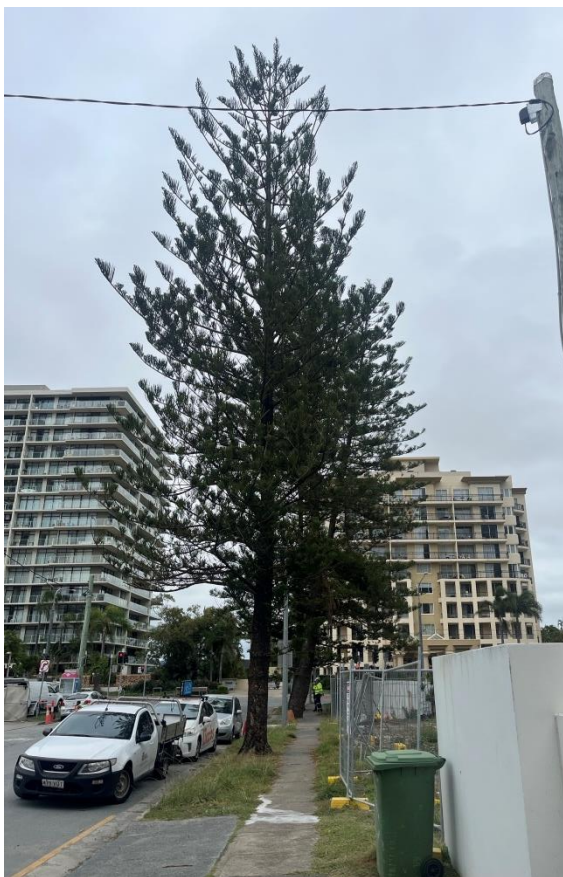
| Tree ID | Scientific name<br>/ Common name | Age class | DSH /<br>DAB<br>(cm) | Height /<br>Crown<br>spread<br>(m) | Health / Form | NRZ / SRZ<br>radius (m) | NRZ / SRZ<br>area (m <sup>2</sup> ) | Distance to development (m)<br>/ Observations | NRZ<br>encroachment<br>(%) | Retain /<br>Remove |
|---|---|---|---|---|---|---|---|---|---|---|
| 1 | <i>Araucaria heterophylla</i><br>(Norfolk Island Pine) | Mature | 55/61 | 17/15 | Good/Good | 6.6/2.6 | 136/22.7 | 3m straight edge on grade/Typical form roots lifting footpath. | 23%<br>Major >20% | Retain |
| 2 | <i>Araucaria heterophylla</i><br>(Norfolk Island Pine) | Mature | 73/79 | 22/7 | Good/Fair | 8.8/2.9 | 241/28 | 5m straight edge on grade/Phototropic lean-to northwest, lifting footpath. | 30%<br>Major >20% | Retain |

*Image 1 – Tree 1 and 2 behind*

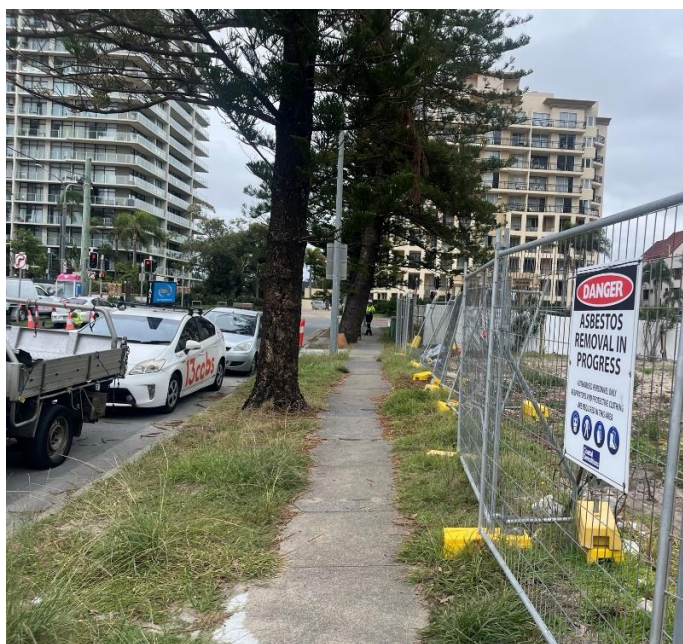
*Image 2 – Base of Tree 1 and 2*

Prior to the commencement of works, both trees will be protected in accordance with AS 4970–2025. Tree Protection Fencing (TPF) will be installed along the property boundary adjacent to the nominated TPZ limits and maintained for the duration of construction works. In addition, both trees will require stem protection (wrapping) to prevent mechanical damage.

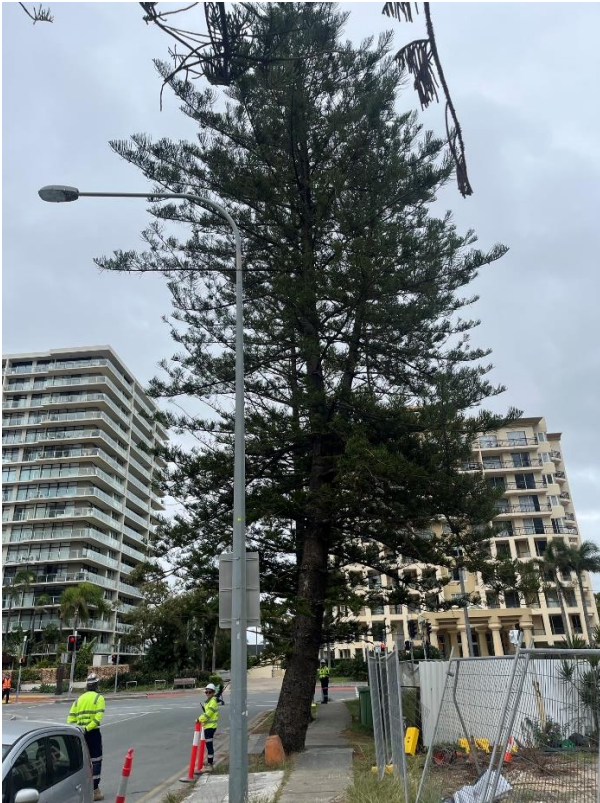
| Tree ID | Scientific name<br>/ Common name | Age class | DSH /<br>DAB<br>(cm) | Height /<br>Crown<br>spread<br>(m) | Health / Form | NRZ / SRZ<br>radius (m) | NRZ / SRZ<br>area (m <sup>2</sup> ) | Distance to development (m)<br>/ Observations | NRZ<br>encroachment<br>(%) | Retain /<br>Remove |
|---|---|---|---|---|---|---|---|---|---|---|
| 3 | <i>Araucaria heterophylla</i><br>(Norfolk Island Pine) | Mature | 78/83 | 24/7 | Fair/Poor | 9.4/3 | 275/29 | 2.4m straight edge/ Bifurcated lean-to northwest, lifting footpath. | 34%<br>Major >20% | Remove |

*Image 3 – Tree 3 Bifurcation*

**Trees 1 and 2** are detailed in Table 1 – Tree Data and are proposed to be retained and managed throughout the construction process in accordance with AS 4970–2025 *Protection of Trees on Development Sites*. **Trees 3 and 4** are proposed for removal and replacement with advanced-sized plantings of *Araucaria columnaris* (Cook Pine).

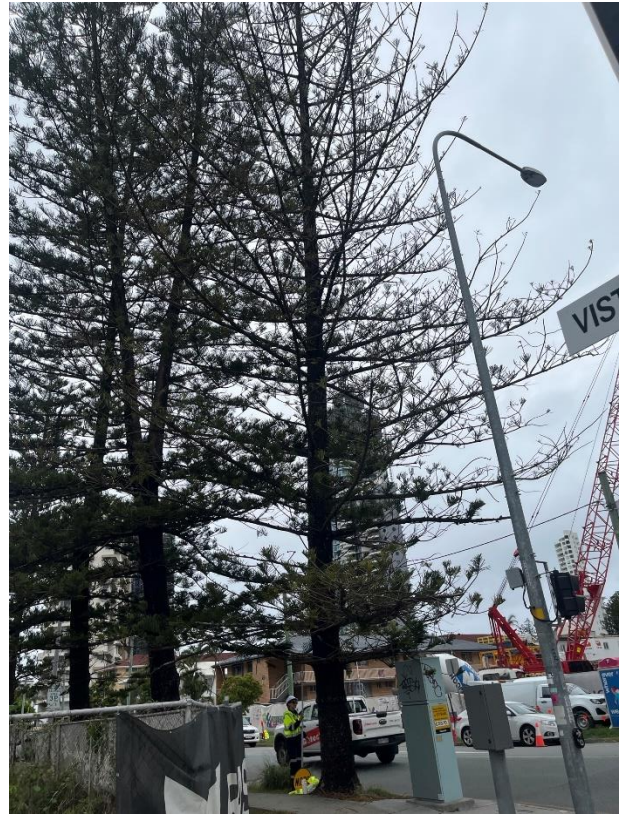
| Tree ID | Scientific name<br>/ Common name | Age class | DSH /<br>DAB<br>(cm) | Height /<br>Crown<br>spread<br>(m) | Health / Form | NRZ / SRZ<br>radius (m) | NRZ / SRZ<br>area (m <sup>2</sup> ) | Distance to development (m)<br>/ Observations | NRZ<br>encroachment<br>(%) | Retain /<br>Remove |
|---|---|---|---|---|---|---|---|---|---|---|
| 4 | <i>Araucaria heterophylla</i><br>(Norfolk Island Pine) | Mature | 60/65 | 22/6 | Poor/Poor | 7.2/2.7 | 62/23 | 4.8m straight edge/Reduced vigour, tree in major decline prior to demolition. | 10.9%<br>Moderate<br>10-20% | Remove |

*Image 4 – Tree 3 left, Tree 4 in decline centre.*

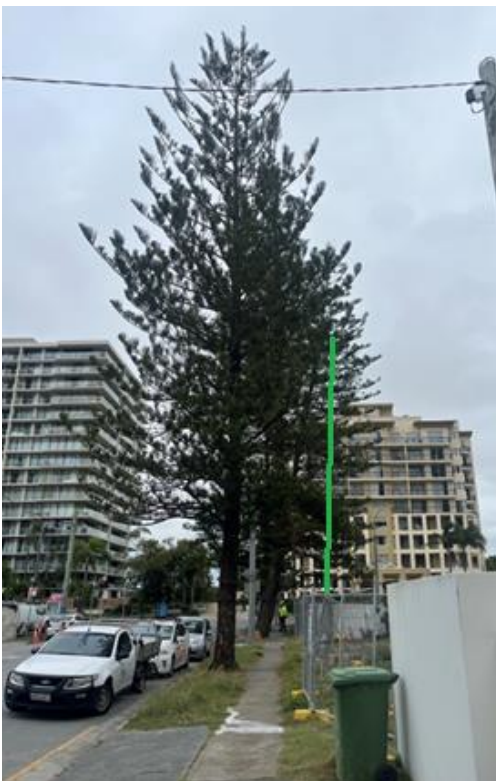
*Image 5 – Extent of lower canopy reduction for Trees 1 and 2*

Council Senior Arboricultural Assessment Officer also supports canopy reduction back to the boundary for the remaining two Norfolk Island Pines to facilitate scaffolding and construction activity.
