# REHABILITATION REPORT

82 Christensen Road, Stapylton

i<sup>3</sup> consulting was commissioned by Amgrow Pty Ltd to prepare reporting on the completed rehabilitation works for the site at 82 Christensen Road, Stapylton, on land described as Lot 500 on SP295994.

The purpose of this Rehabilitation Report is to demonstrate that remediation works have been completed on the lower proposed lease area of the site.

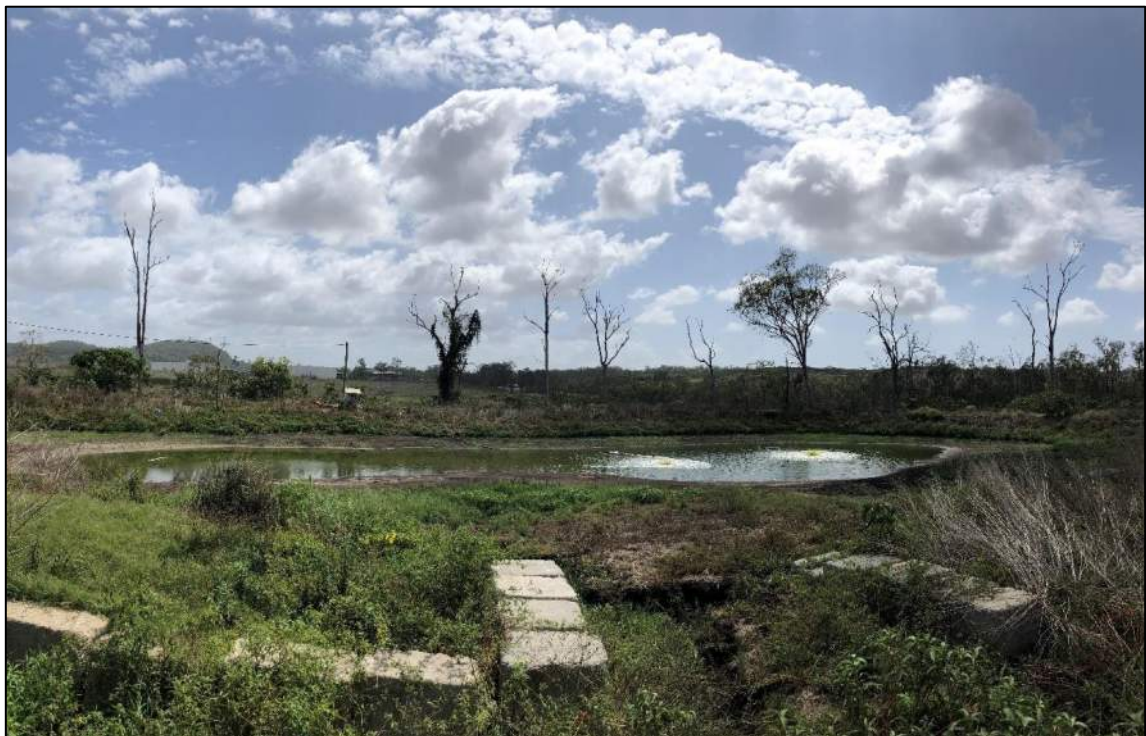
Figure 4: Dam on North-Eastern corner prior to rehabilitation works (October, 2019)

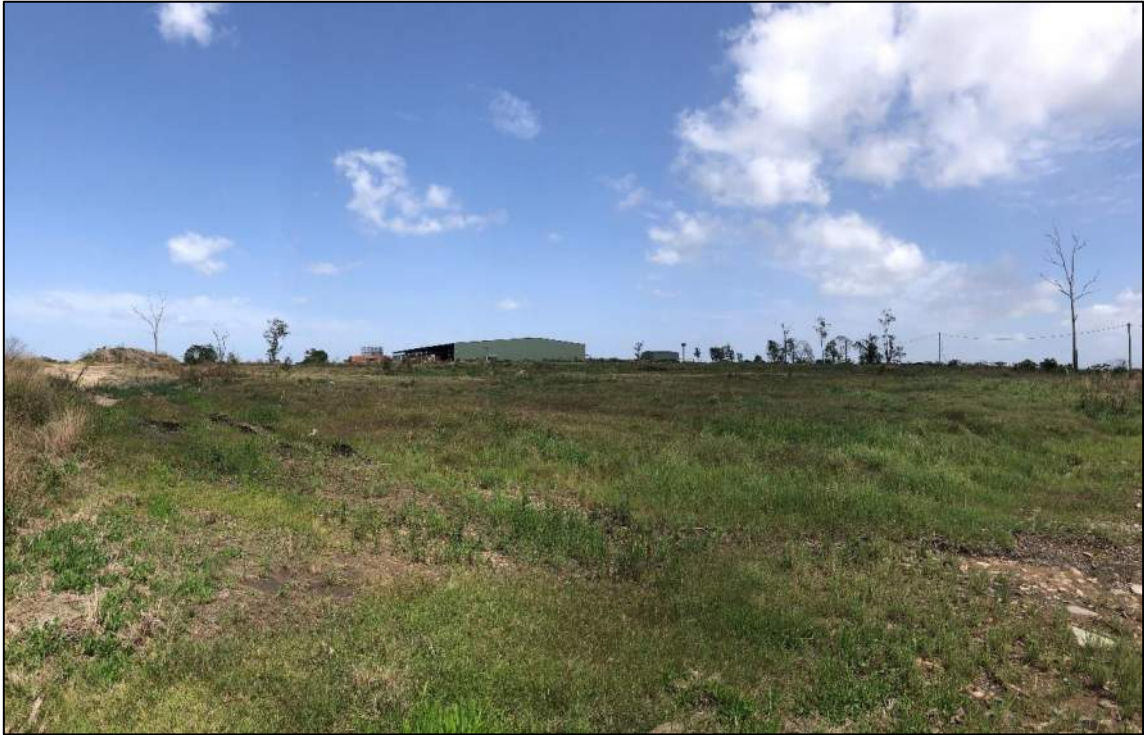
Figure 5: Dam on North-Eastern corner prior to rehabilitation works (October, 2019)

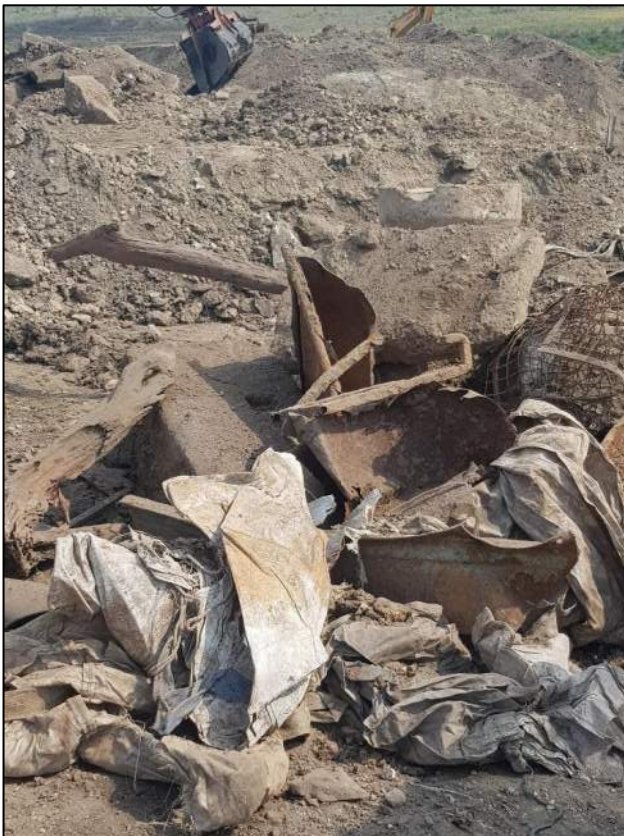
Figure 6: Debris removal during rehabilitation works (December, 2019)

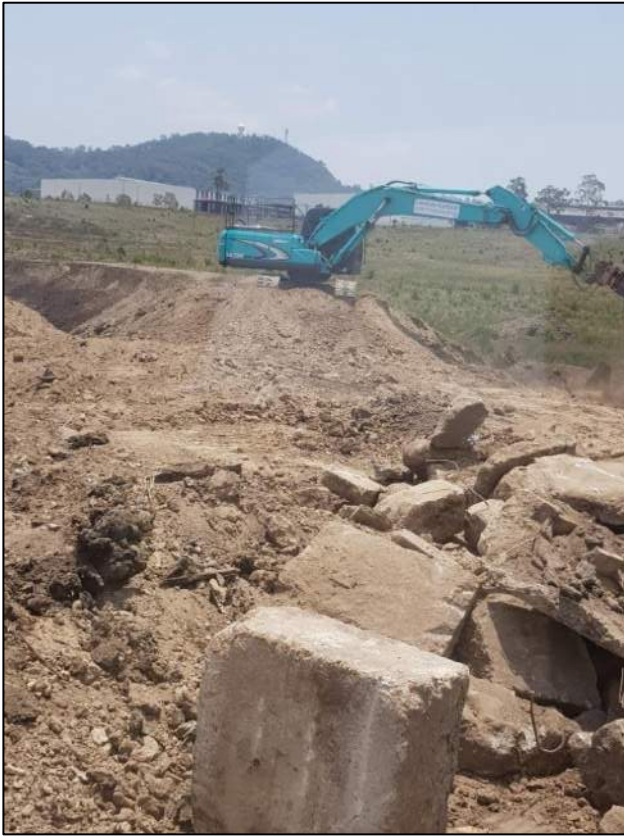
**Figure 7: Concrete block removal during rehabilitation works (December, 2019)**

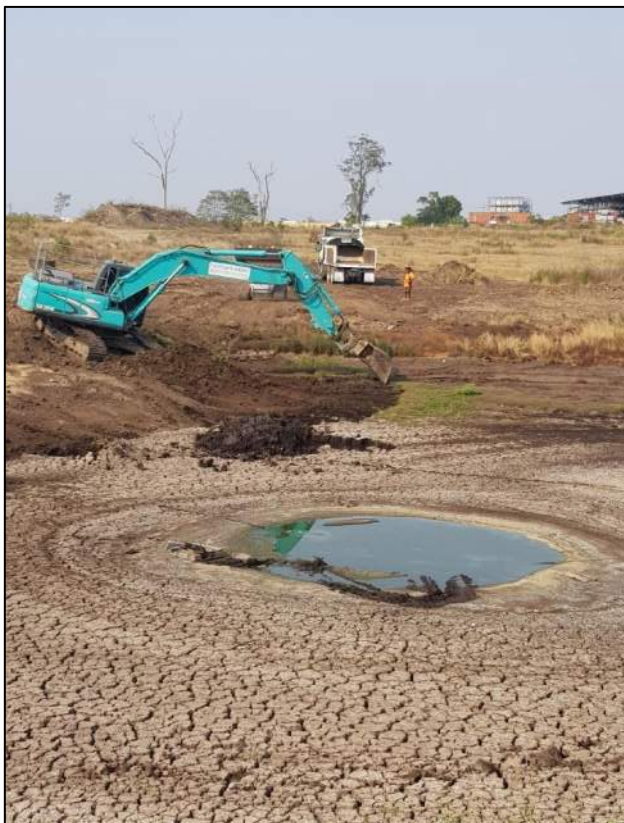
**Figure 8: Removal of unsuitable subgrade (December, 2019)**

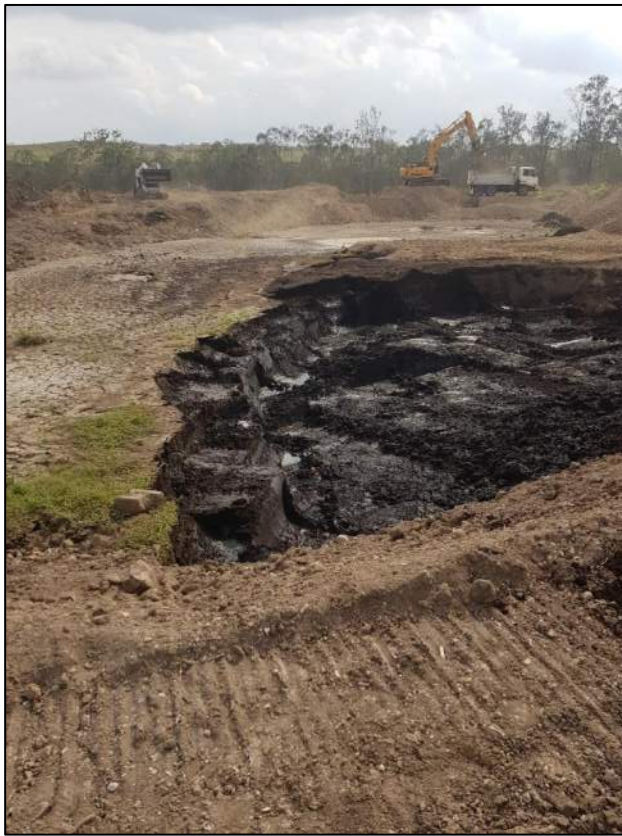
**Figure 9: Removal of unsuitable subgrade (December, 2019)**

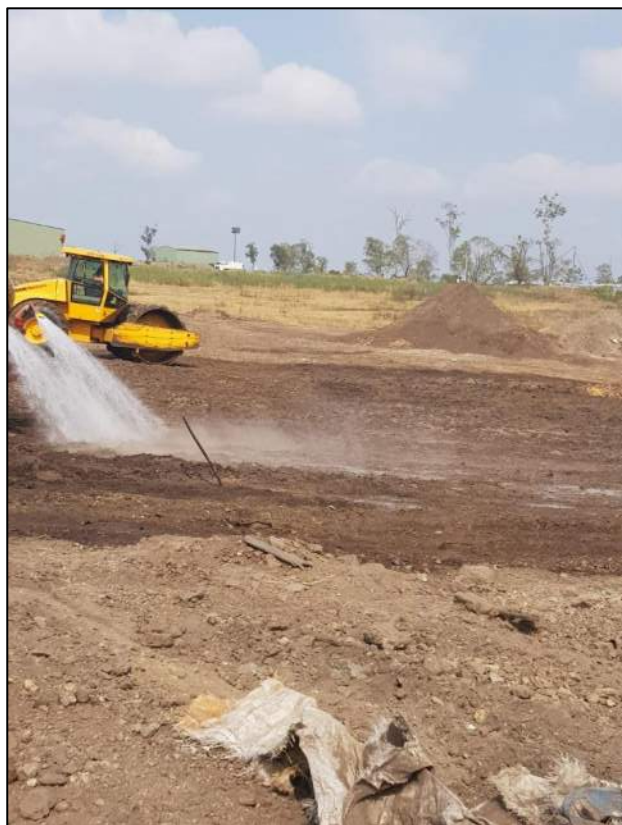
**Figure 10: General earthworks (December, 2019)**

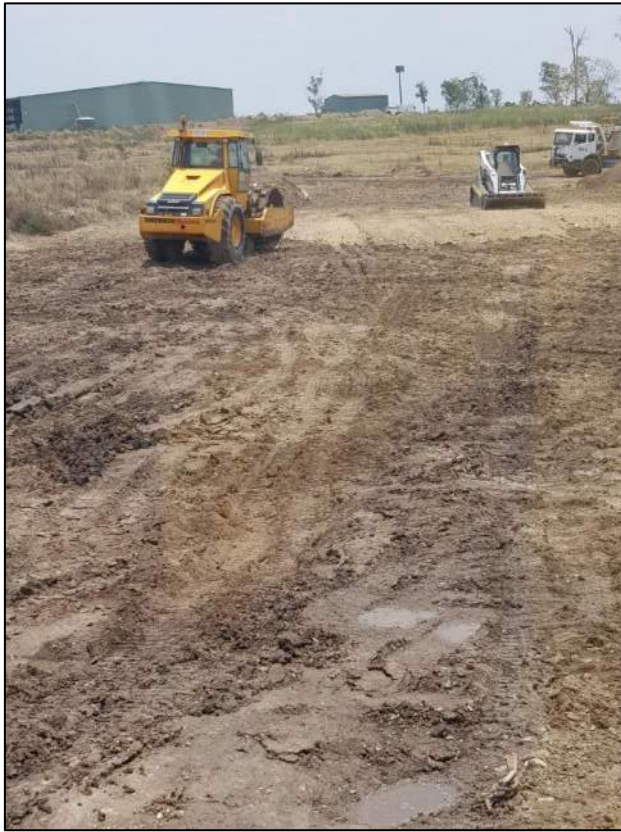
**Figure 11: General earthworks (December, 2019)**

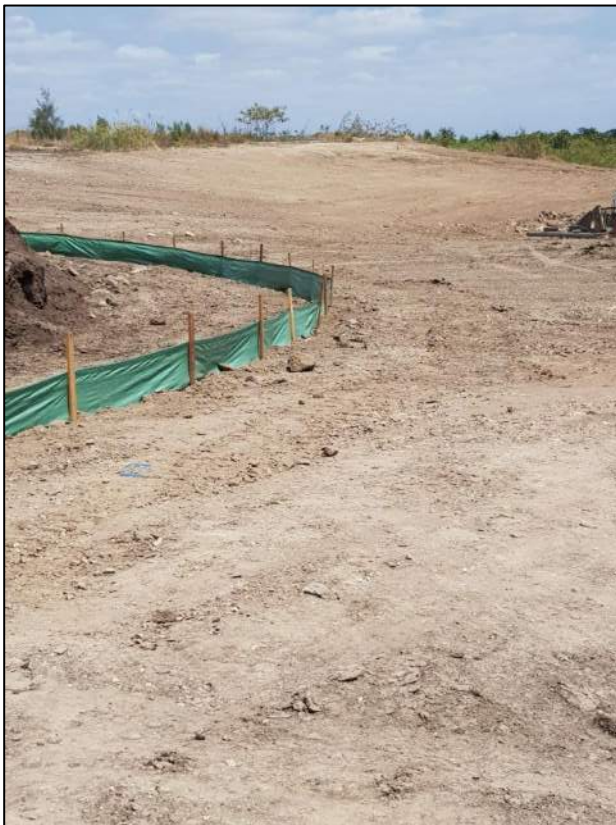
**Figure 12: General earthworks (December, 2019)**

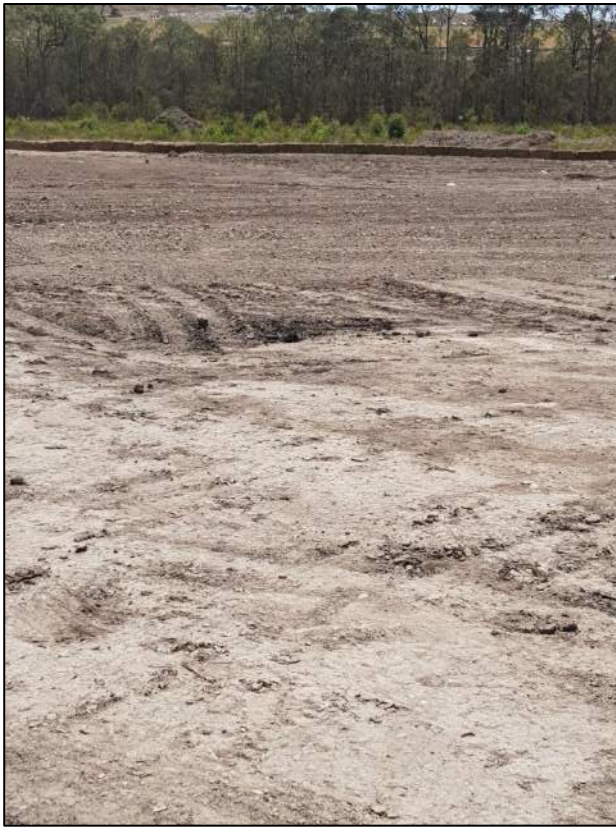
**Figure 13: General earthworks showing hay bales as sediment and erosion control (December, 2019)**

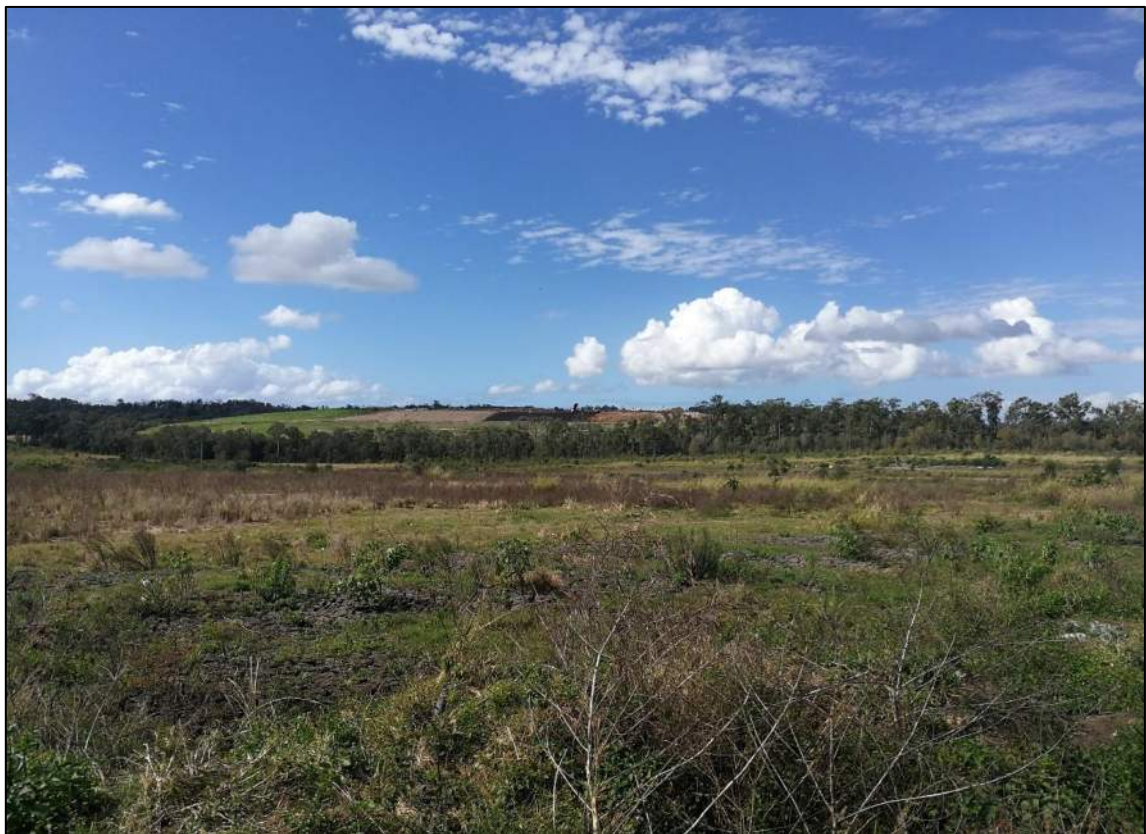
**Figure 14: Regrowth (August, 2020)**

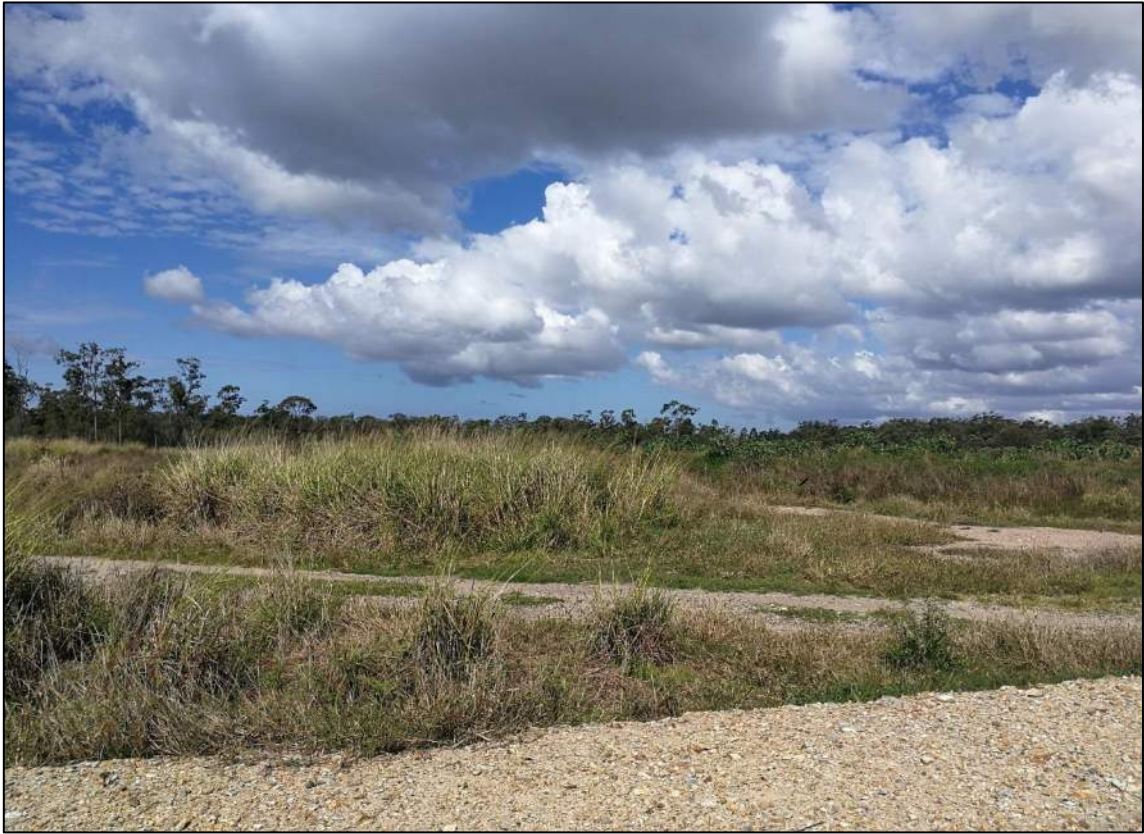
**Figure 15: Regrowth (August, 2020)**

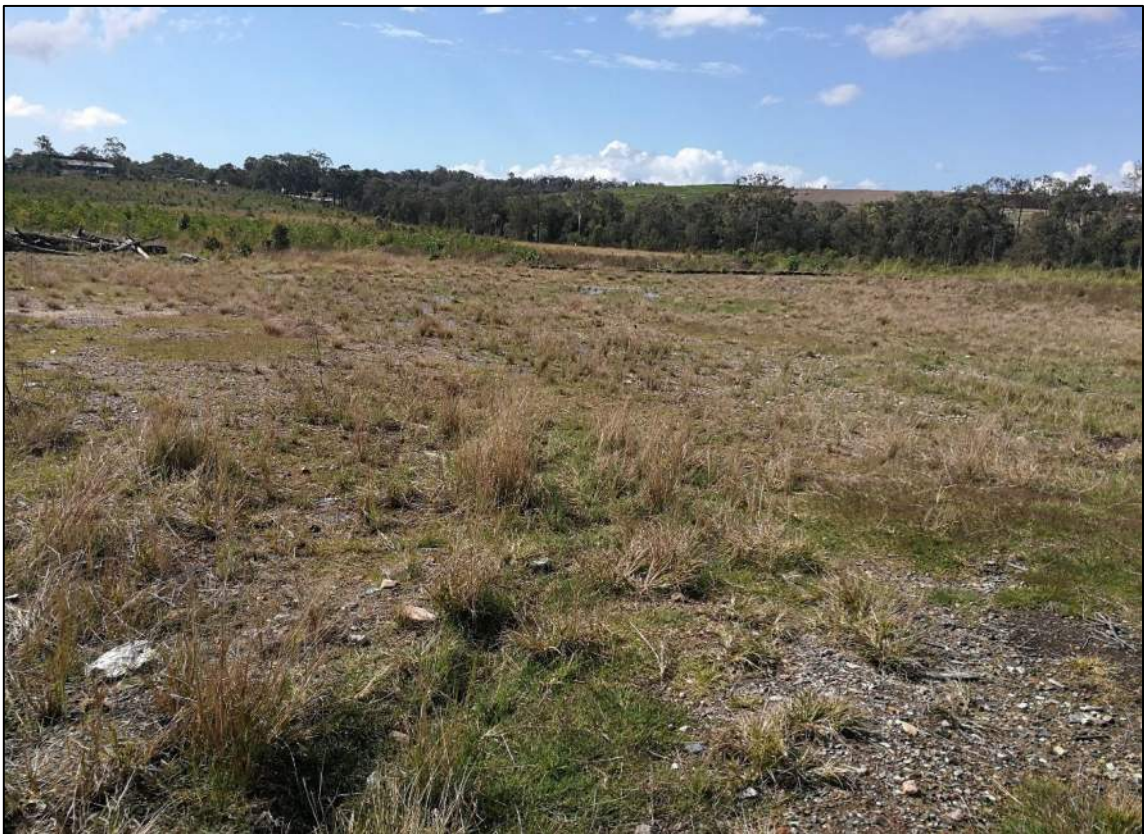
**Figure 16: Regrowth (August, 2020)**

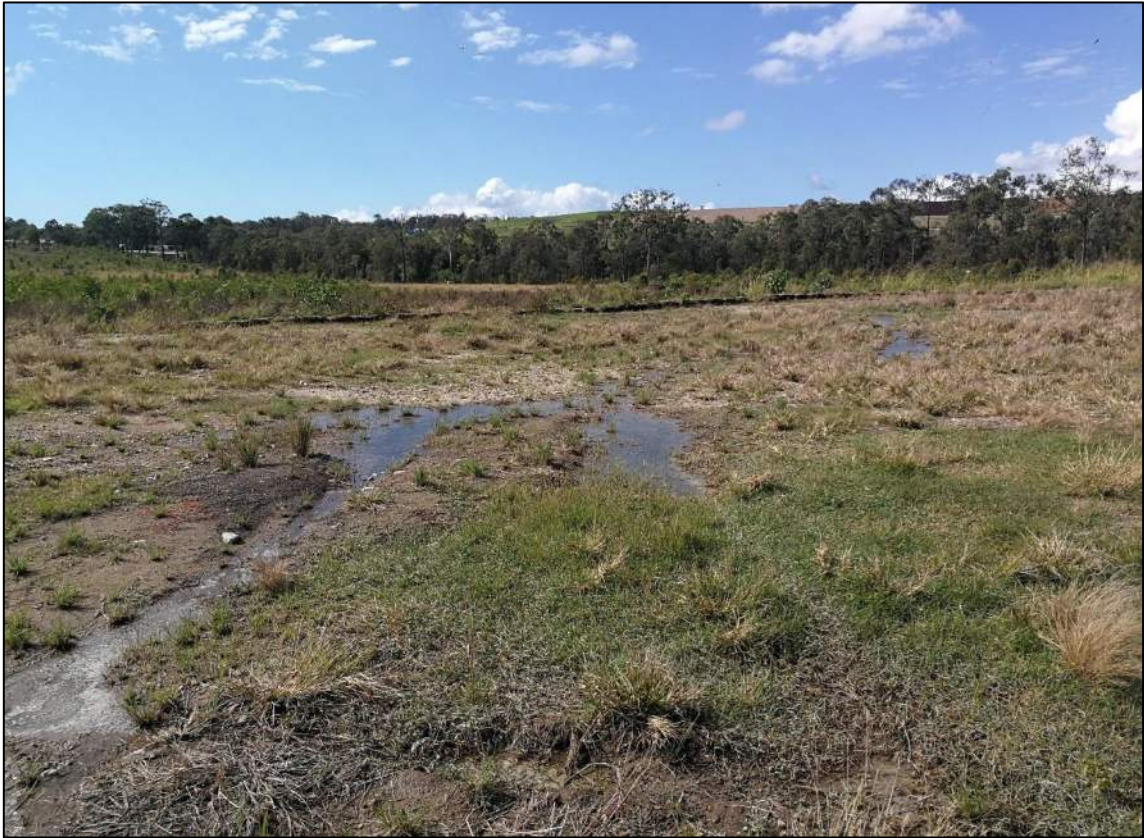
**Figure 17: Regrowth (August, 2020)**

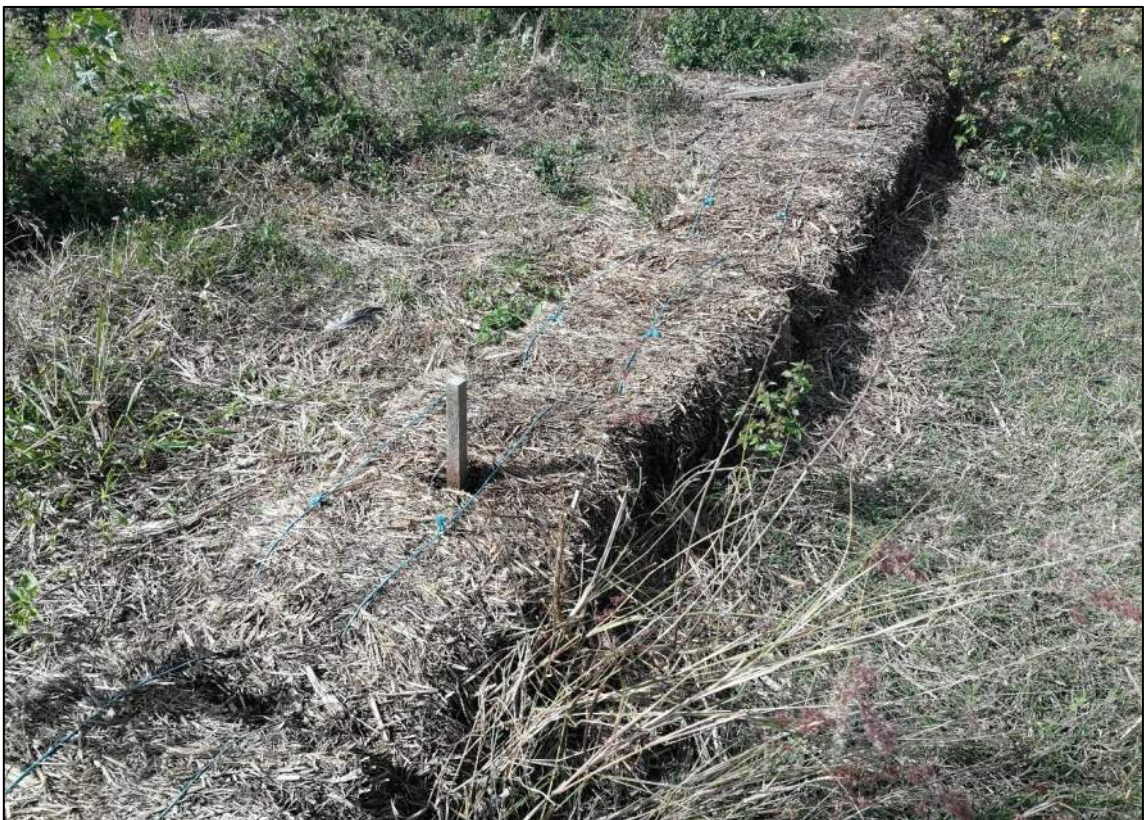
**Figure 18: Hay Bale Sediment Control and Filtration (August, 2020)**

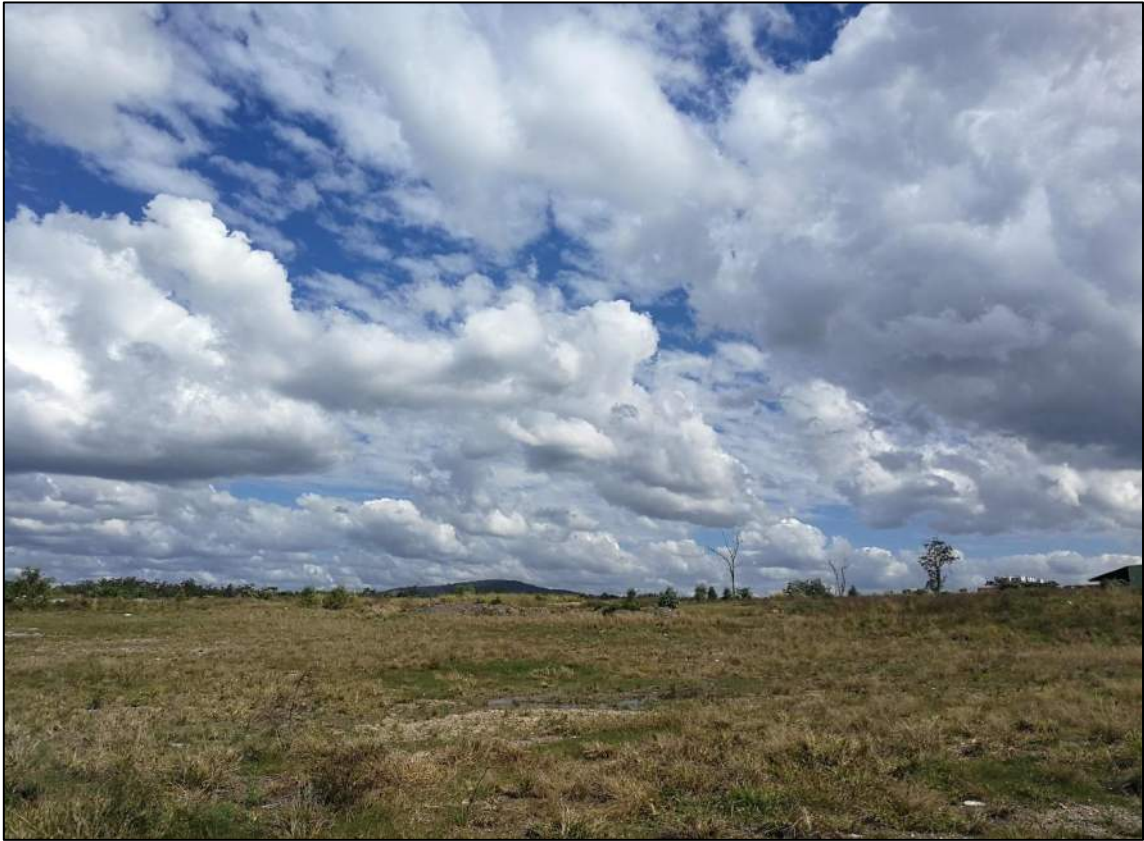
**Figure 19: Regrowth (August, 2020)**
