**Geotechnical Investigation  
& Landslide Risk Assessment  
Proposed Residential Development  
#17 Courtney Drive,  
Upper Coomera QLD 4209**

### Geotechnical Investigation & Landslide Risk Assessment Proposed Residential Development 17 Courtney Drive, Upper Coomera, QLD 4209

### Interpretative Report

Report Ref. No: 9603 Rev E – 25-474

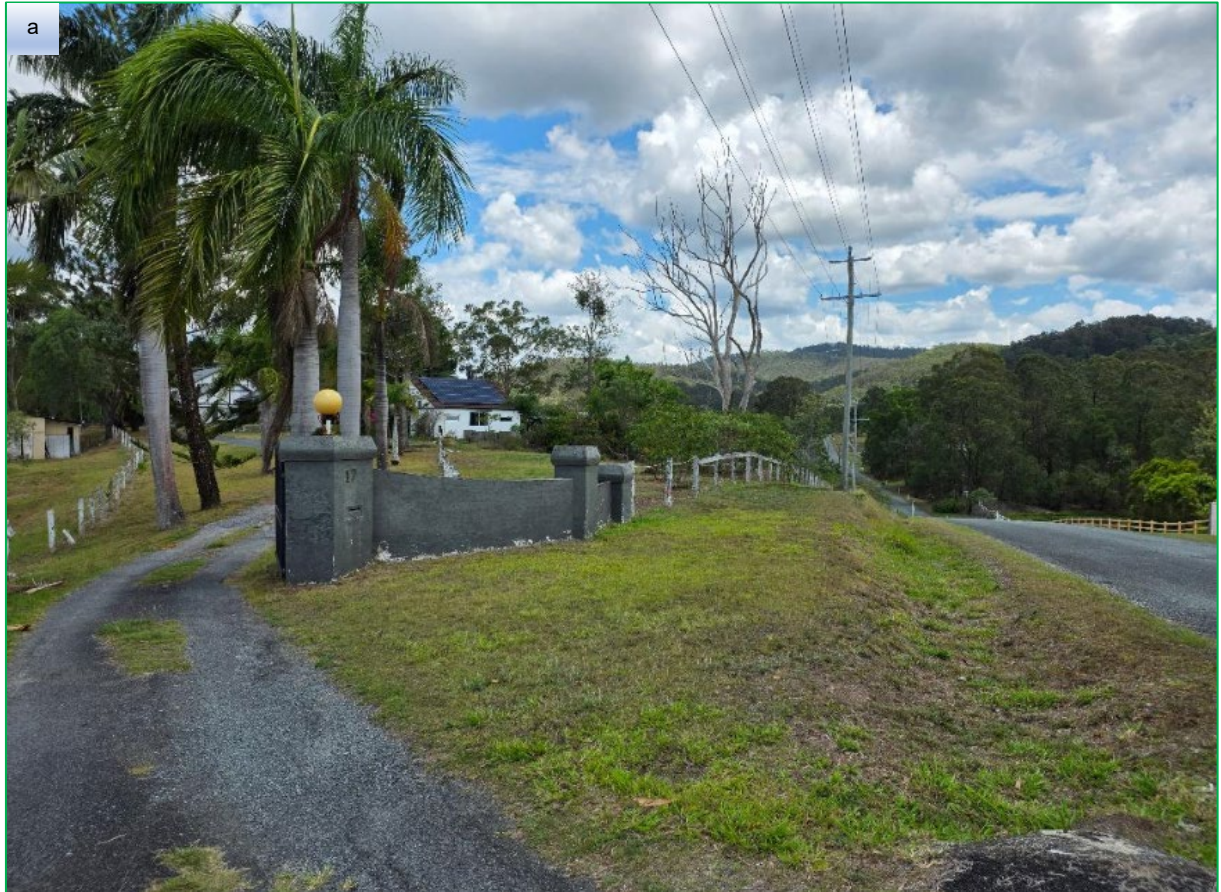
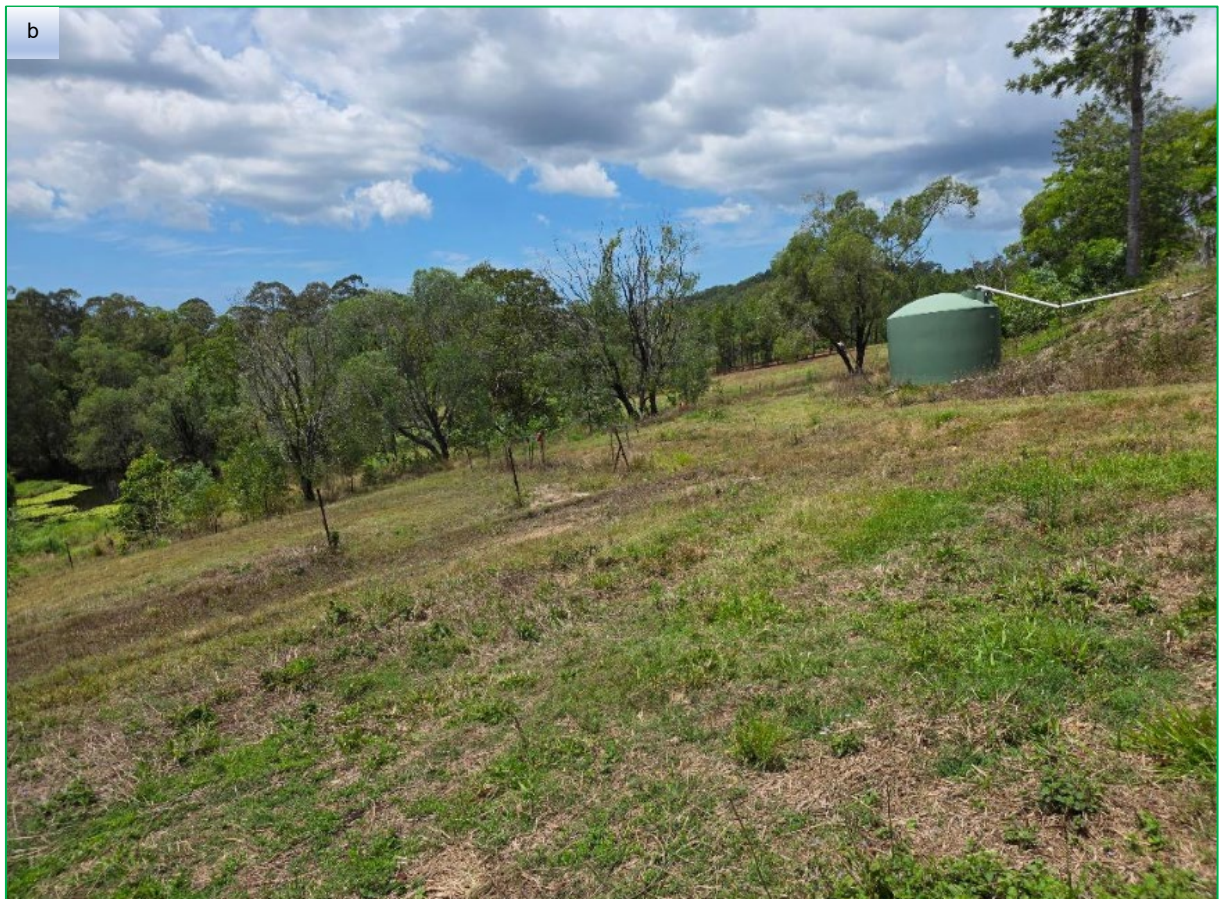
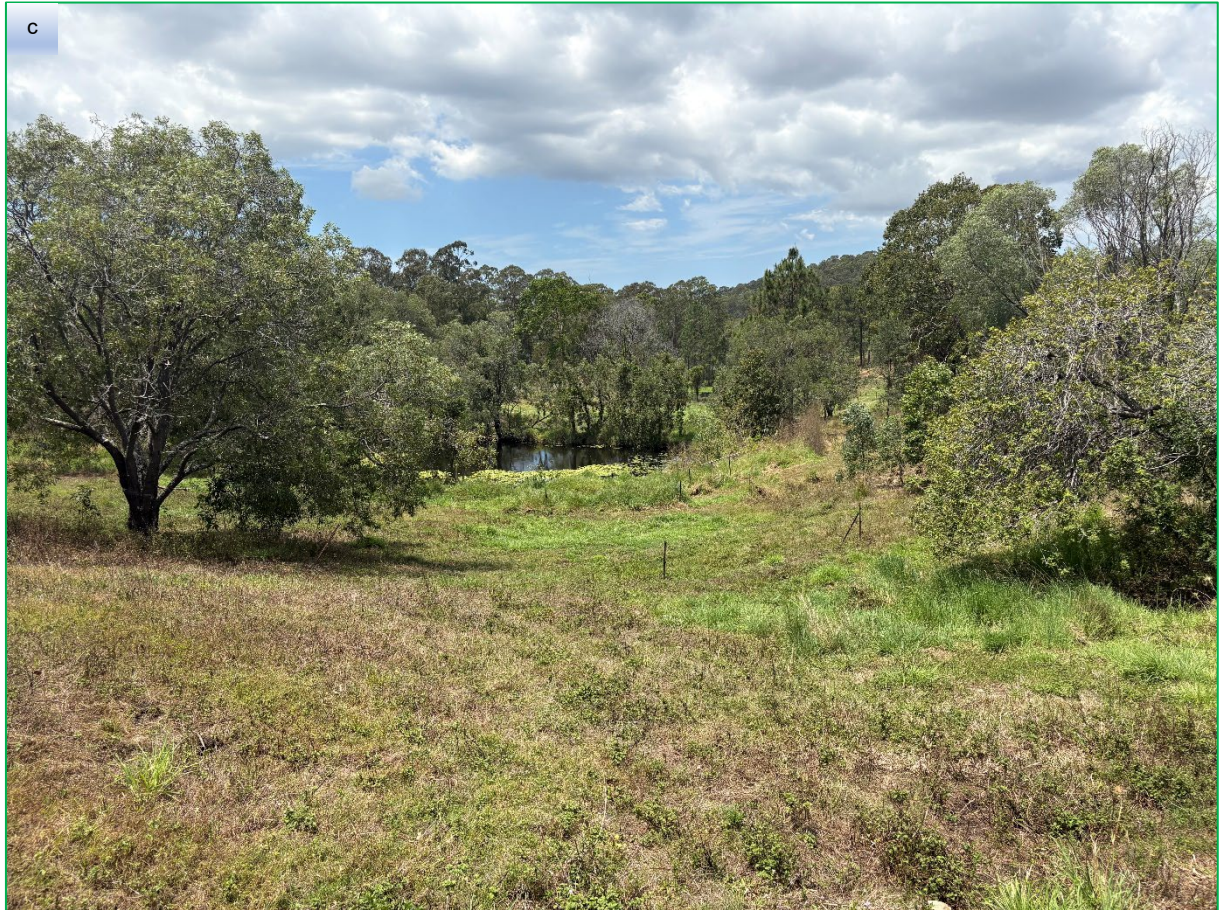
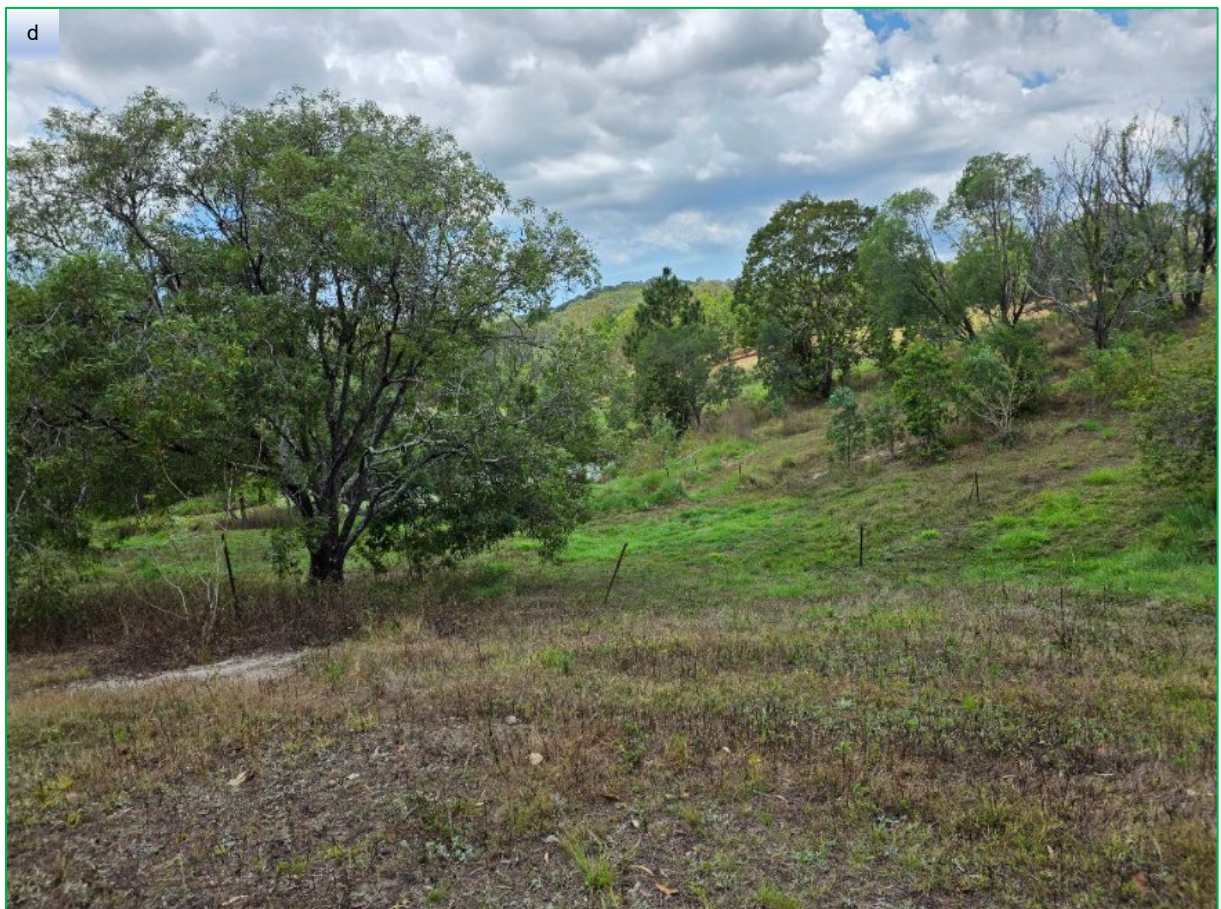
Figure 4a, b, c & d: Selected Photographs of the Site
