**RE: RESPONSE TO INFORMATION REQUEST FOR OPW201801218 &  
OPW201801219  
OPERATIONAL WORKS FOR VEGETATION CLEARING AND CHANGE TO  
GROUND LEVEL**

**Property: Lot 1 on RP6882, 60 Stapylton Jacobs Well Road & Lot 240 on W31320, 82  
Christensen Road, Stapylton**

# VEGETATION MANAGEMENT PLAN v2

Fauna Management Plan  
Stage 2  
60 Stapylton Jacobs Well Road  
82 Christensen Road

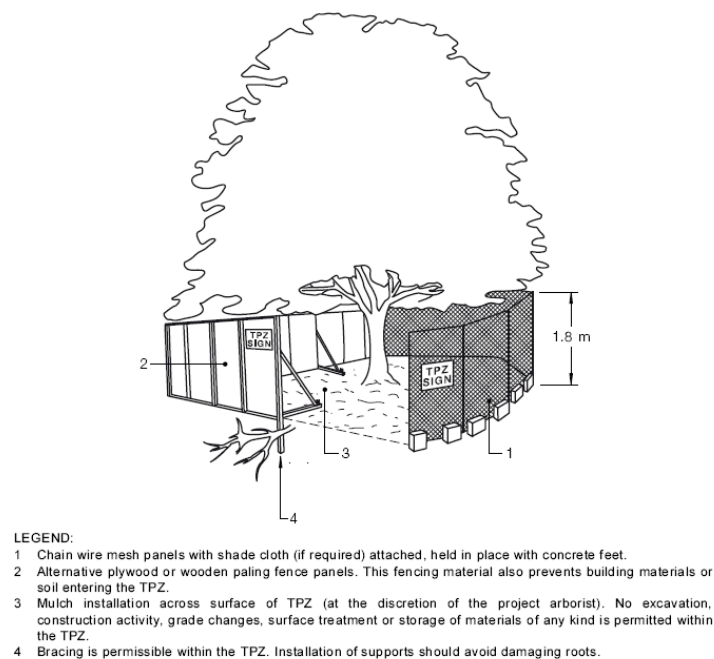
Figure 3: Individual Tree Protection

However, the area of 240 on W31320 to the south of Christensen Road will require protection for the vegetation to be retained within the required buffer area to Sandy Creek. Because of the scale of the clearing, hard standing steel fence (Figure 3) as per Australian Standard AS 4970-2009 (Protection of Trees on Development Sites) is not a feasible option for protecting retained vegetation. Instead, orange mesh fencing between steel pickets and supported by a continuous wire will be utilised to clearly mark the extent of clearing associated with this balance of earthworks VMP.

- 1) The limit of the balance of earthworks extent in the portion of Lot 240 W31320 south of Christensen Rd will be clearly demarcated with orange mesh fencing between steel pickets and supported by a continuous wire
- 2) All machine operators conducting the tree clearing process are to have a copy of the approved Tree Clearing Plan;
- 3) No site sheds, parking areas or buildings are located within the retained vegetation outside of the balance of earthworks clearing extent, or under its drip line;
- 4) The area surrounding the trees for removal is clear of any hazards and maintains adequate room to safely conduct the removal;
- 5) The vegetation removal process has focused on providing environmentally sensitive and sustainable practices including:

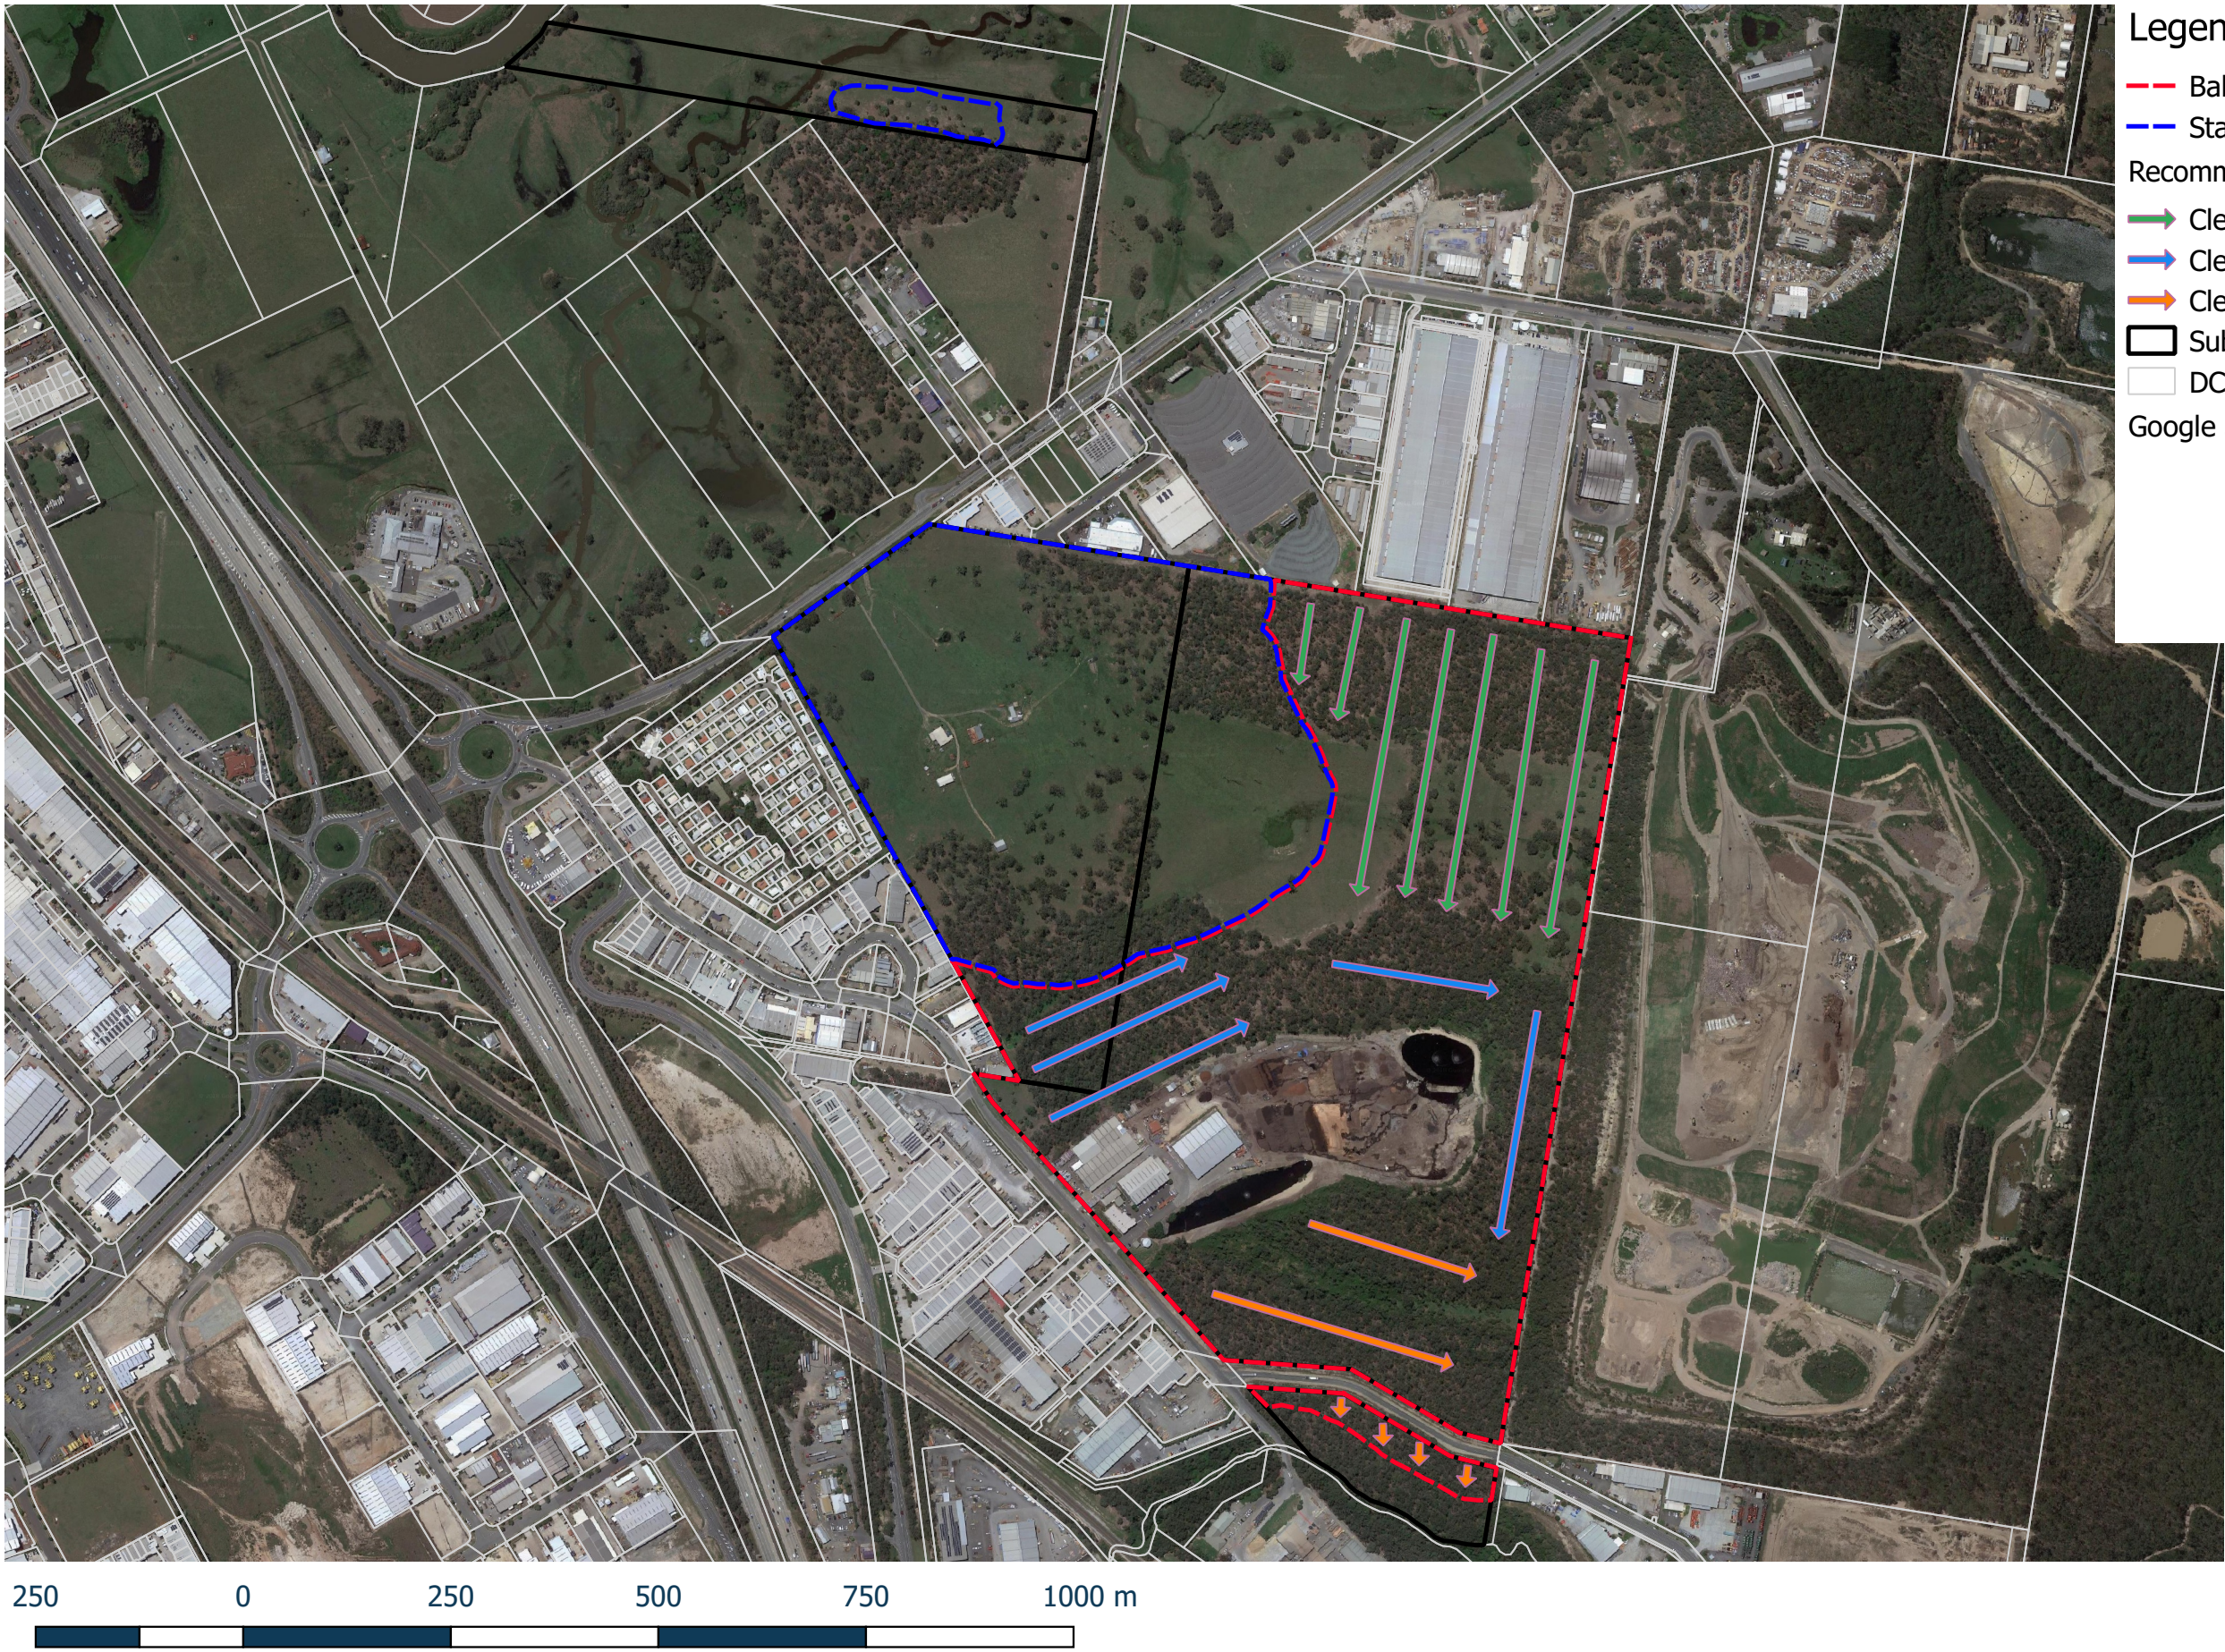
- 3) Fell the allocated vegetation; where practical ensure that clearing occurs in the recommended clearance direction (Figure 4) or in accordance with Fauna Spotter Catcher directions, in order to direct fauna towards retained vegetation and away from adjacent roads.

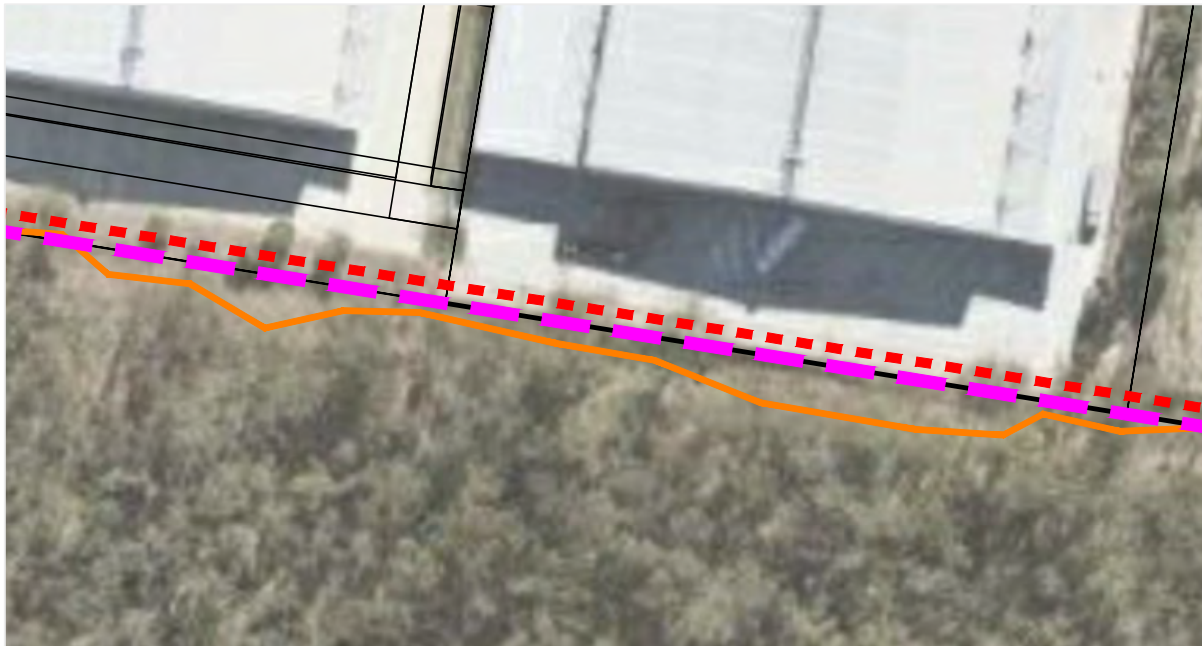
## Appendix 1 – Tree Survey Plan

- SITE BOUNDARY
- STAGE 1 VMP (REFER TO DWG 5738 E VMP TSP S 00)
- EARTHWORKS EXTENT OF BALANCE
- TREE GROUP TO BE REMOVED
- TREES TO BE REMOVED

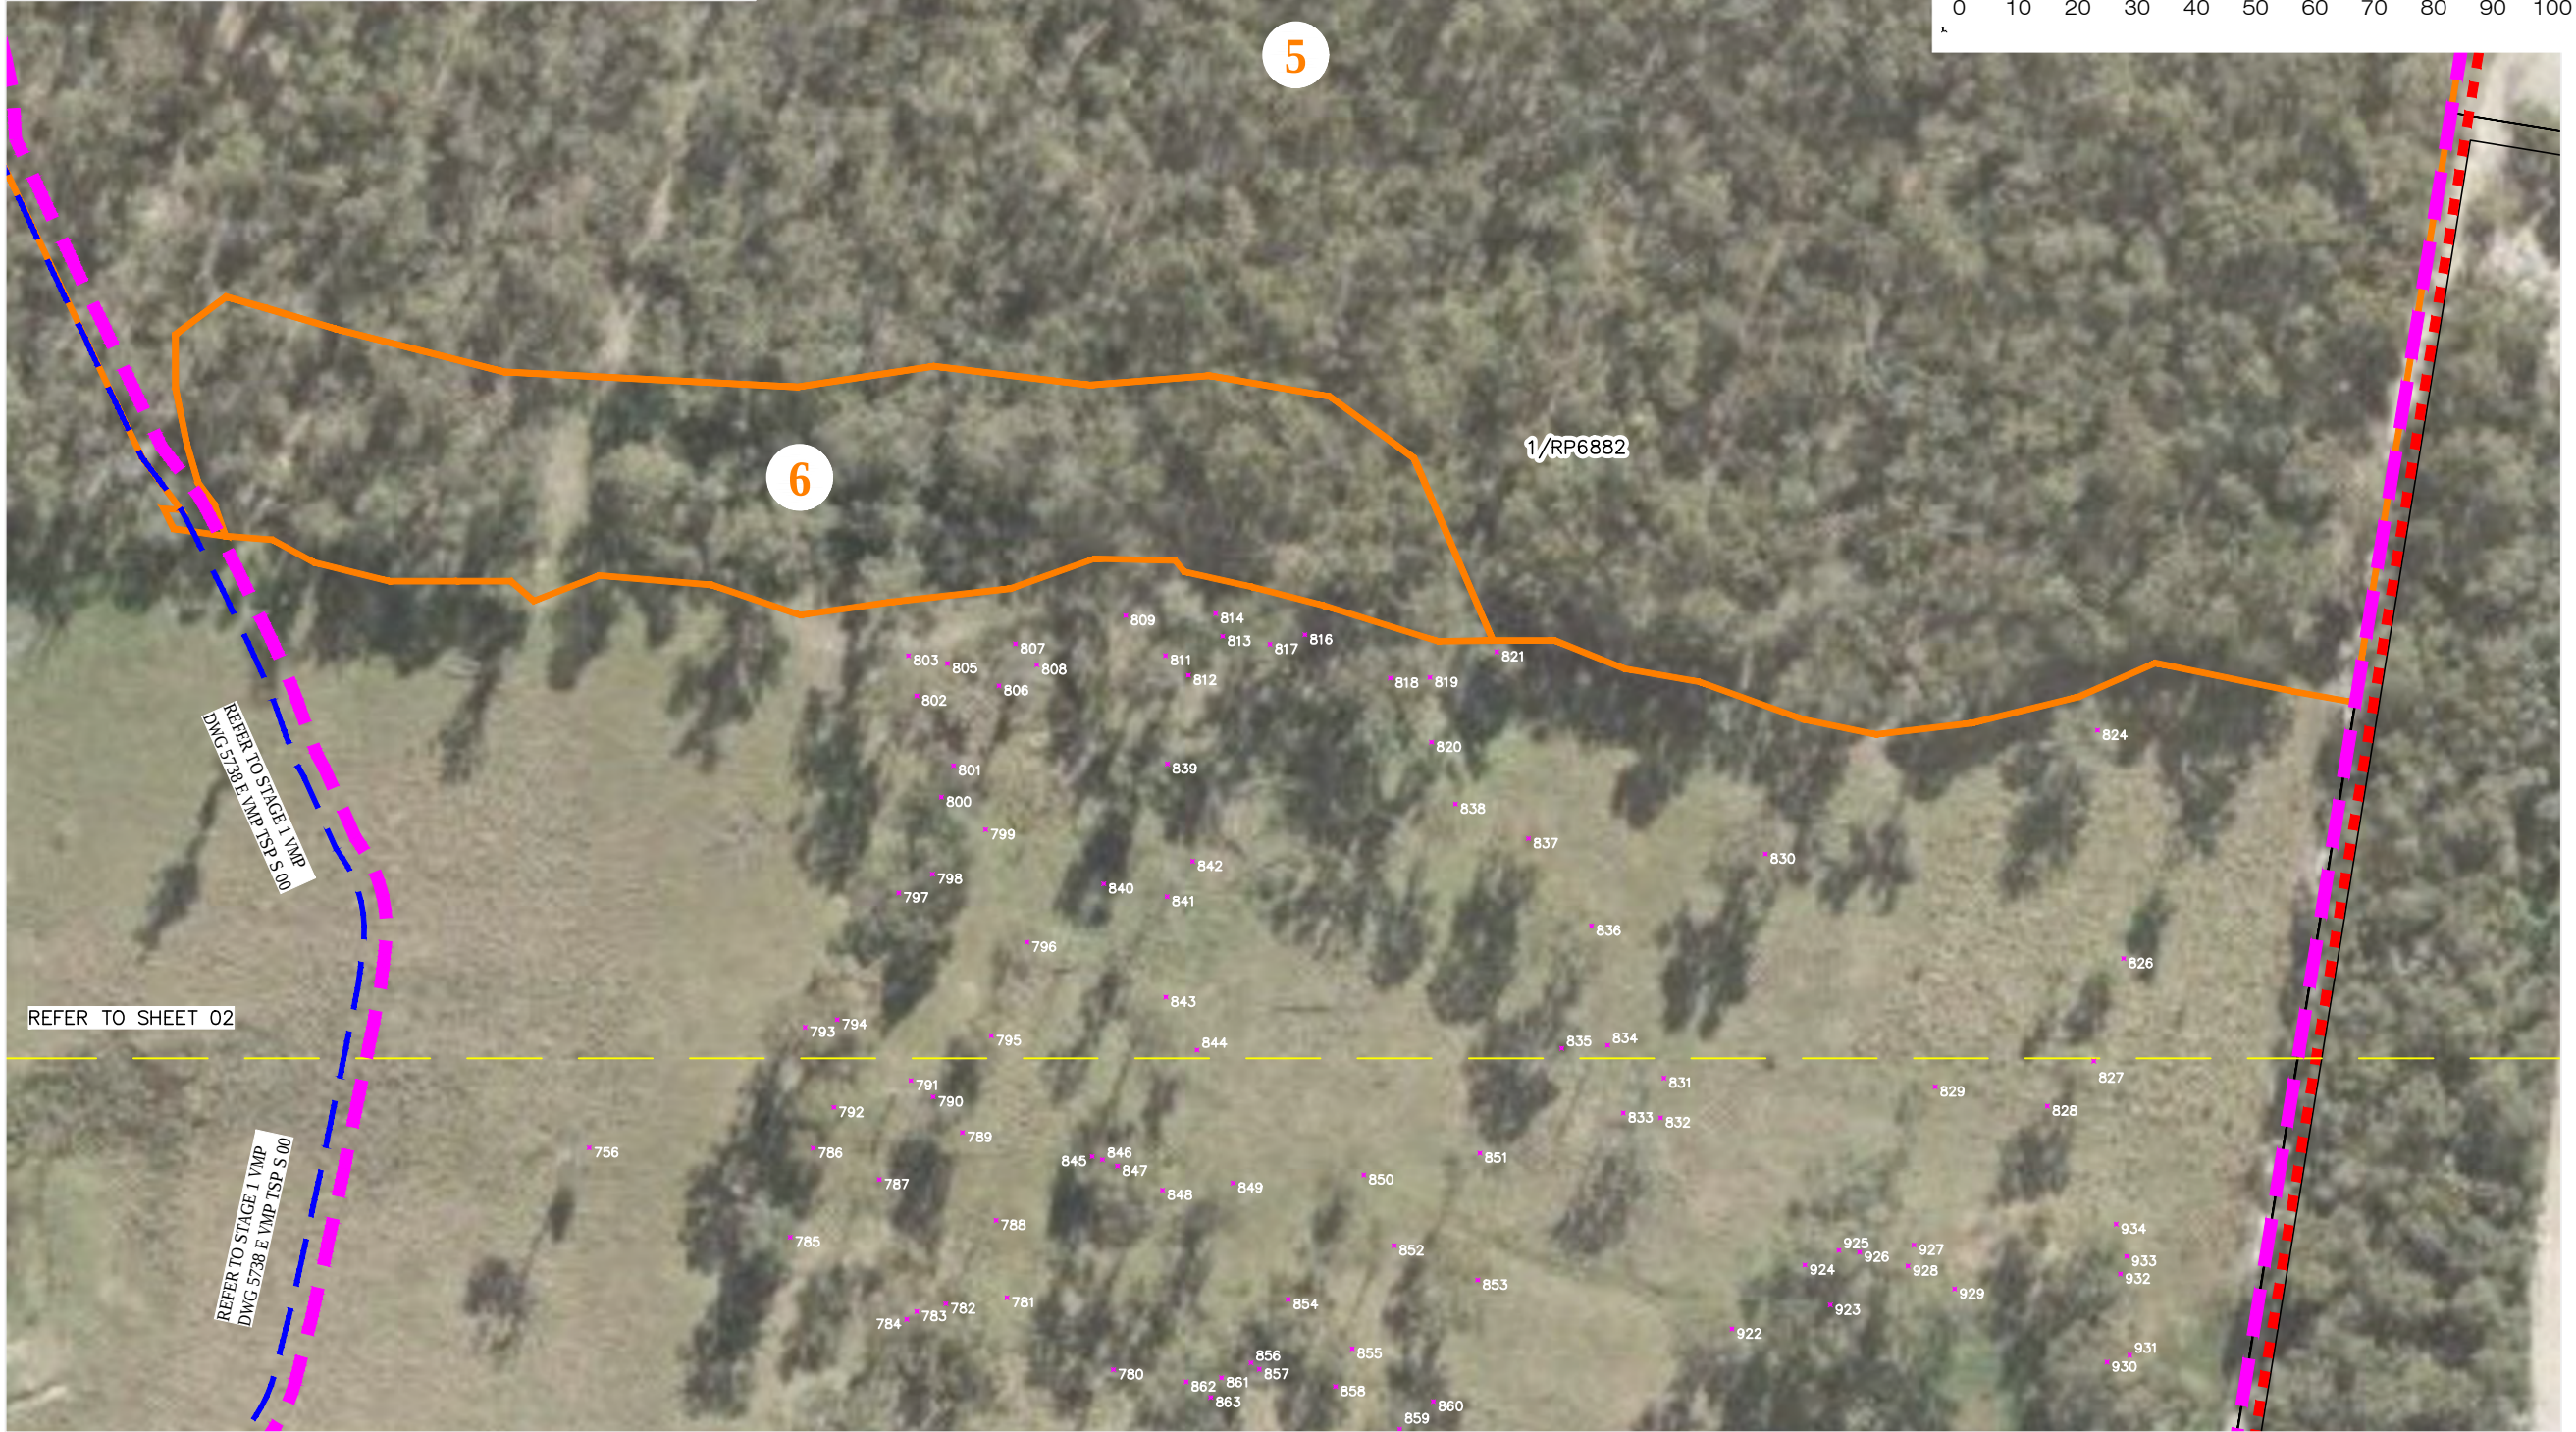
Drawing Title:  
**TREE SURVEY PLAN  
BALANCE**  
**SHEET 01 OF 06**

Details of individual trees recorded on the subject site include the species, trunk diameter, height, canopy spread and fauna use.

Trees were recorded using survey equipment and methods. This information has been used for the best practice management strategies for managing clearing on the site. The records of these trees are included in Appendix 1 to this report.

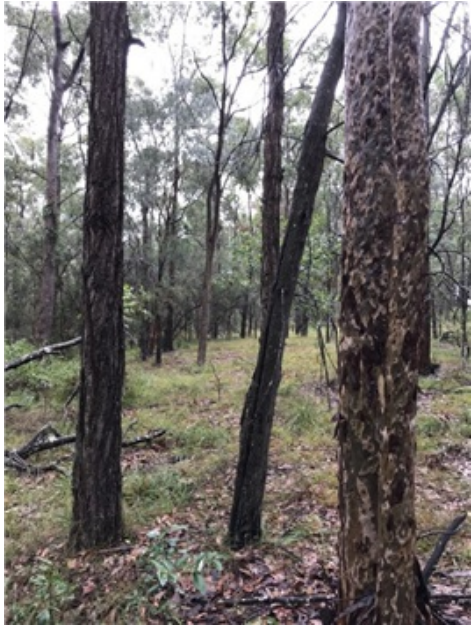
Plate 1: Mature vegetation

3.2.8 arboreal nests  
3.2.9 scats.  
3.3 The review of the ecological assessment and the site inspection established the following habitat types:  
3.3.1 mature vegetation with intact crown cover providing habitat for fly through birds (Plate 1)

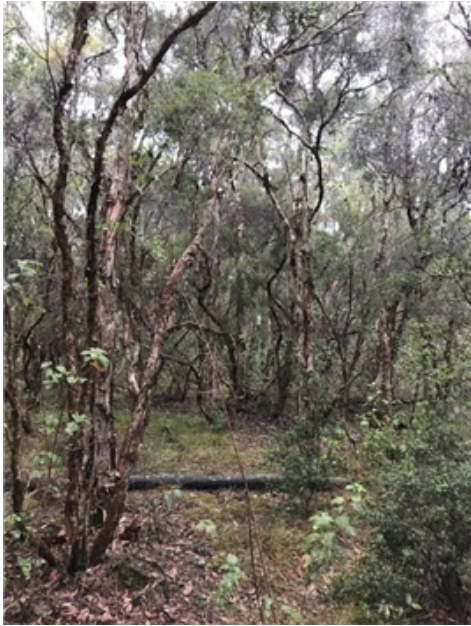
Plate 2: Paperbarks providing microbat habitat

3.3.3 stands of paper bark or tea tree (Melaleuca quinquenervia, Melaleuca decora and Melaleuca linariifolia) with very loose bark which is ideal habitat for micro bats (Plate 2)

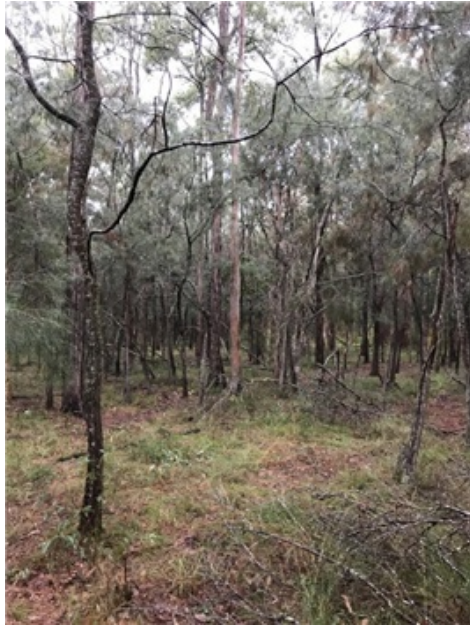
Plate 3: Black she-oak - food source for glossy black cockatoo

3.3.4 stands of black she-oak (Allocasuarina littoralis) which provide a food source for the glossy black cockatoo (Calyptorhynchus lathami) (listed as Vulnerable under the Nature Conservation Act 1992) (Plate 3)

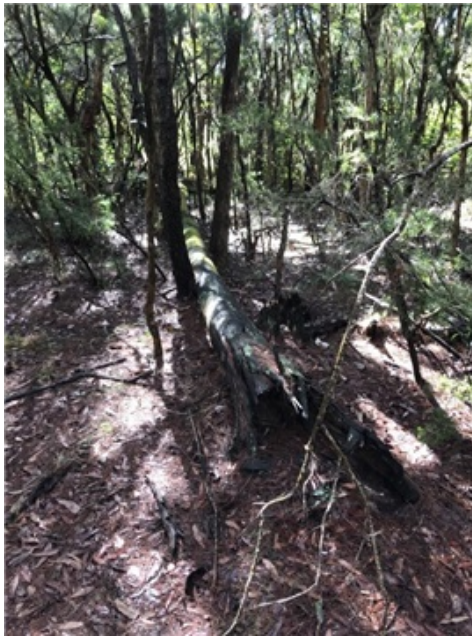
Plate 4: Habitat for small ground-dwelling mammals, reptiles and amphibians

3.3.5 fallen timber, branches and leaf litter offering habitat for small ground-dwelling mammals, reptiles, and amphibians (Plate 4)  
3.3.6 improved pasture/grassland, providing habitat for grassland birds, small ground-dwelling mammals and grazing macropods

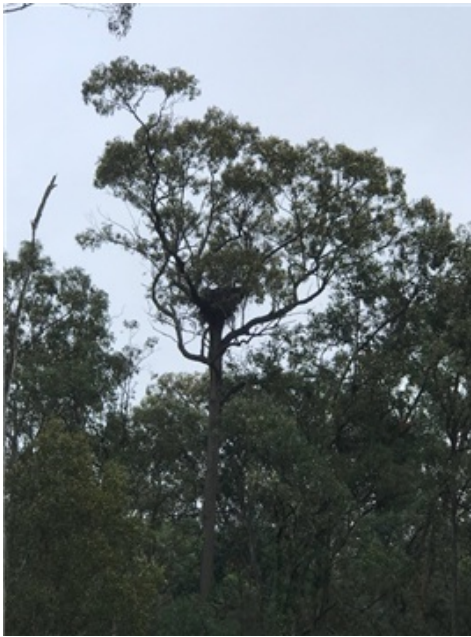
Plate 5: Ironbark with wedge-tailed eagle chicks

3.3.10 an active wedge-tailed eagle nest was observed centrally located within the Stage 2 works area (refer to section 6.0).

6.2 The breeding season of the wedge-tailed eagle in south east Queensland and northern New South Wales is reported to vary between locations although has been noted between April and September, with an incubation period of approximately 45 days and a nestling period of approximately 90 days (Allott et al. 2006, Debus et al. 2007). Once chicks are fledged (where they have reached full development with fully grown adult plumage and are ready to fly), parental dependency may last up to five months (Allott et al. 2006, Debus et al. 2007).

6.3 During the nesting period and up to four weeks after fledging, large birds of prey are considered to be highly susceptible to disturbance within their ranging area, particularly within line of sight of their nests (U.S. Fish and Wildlife Service 1999). A buffer zone up to 1 km for up to four weeks has been recommended for similarly sized birds such as the white-bellied sea eagle (Haliaeetus leucogaster) in Australia (Debus et al. 2014) and the bald eagle Haliaeetus leucocephalus in the United States of America (U.S. Fish and Wildlife Service 1999) and is recommended in the Threatened Tasmanian Eagles Recovery Plan (Threatened Species Section 2006). As there is a break in the line of site from the nest towards the Stage 1 works area, it is recommended to maintain a minimum 500 m exclusion buffer zone around the nest until at minimum four weeks after the chicks fledge, to ensure the parents don't abandon the chicks due to disturbance. It is recommended not to attempt to relocate the wedge-tailed eagle chicks before they become independent.

6.4 It is recommended that a suitably qualified fauna ecologist monitor the progress of the chicks while in the nest and during the first four weeks of fledging. This will aid to ascertain a more precise time of fledging and to provide advice on the timing of clearing works to mitigate the impacts to the wedge-tailed eagles. Clearing should not commence in the Stage 2 works area until advised to do so by a suitably qualified fauna ecologist, based on the risk to the birds' welfare.

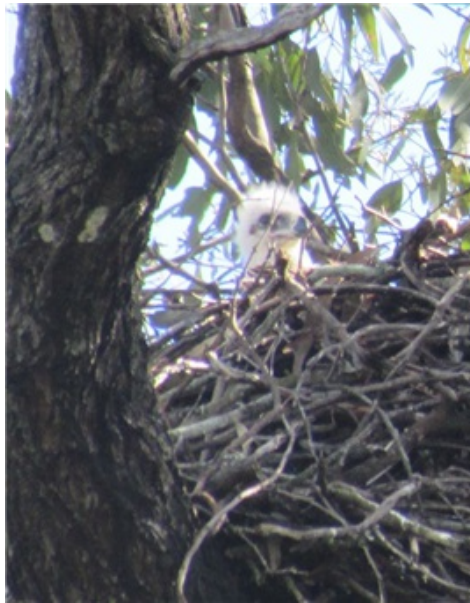
Plate 6: One of the two wedge-tailed eagle chicks

6.1 An active wedge-tailed eagle nest with two chicks was identified in a mature broad-leaved ironbark (Eucalyptus fibrosa) centrally located within the Stage 2 works area on 12 July 2018 (Figure 1, Plate 10 and Plate 11). The chicks were estimated to be approximately 3-4 weeks in age at this time, as downy chicks are reported to be able to raise their heads above the nest-rim at three weeks old (Debus et al. 2007). However, this is only an estimated age as the remaining feathers of the chick were not visible to more accurately determine the age.
