Report on  
Geotechnical Investigation and Preliminary Acid  
Sulfate Soils Assessment

Vantage Estate, Stage 2 - Proposed External Trunk  
Gravity Sewer  
Christensen Road South, Yatala

Prepared for  
Frasers Property Industrial Pty Ltd

Project 206529.00  
February 2022

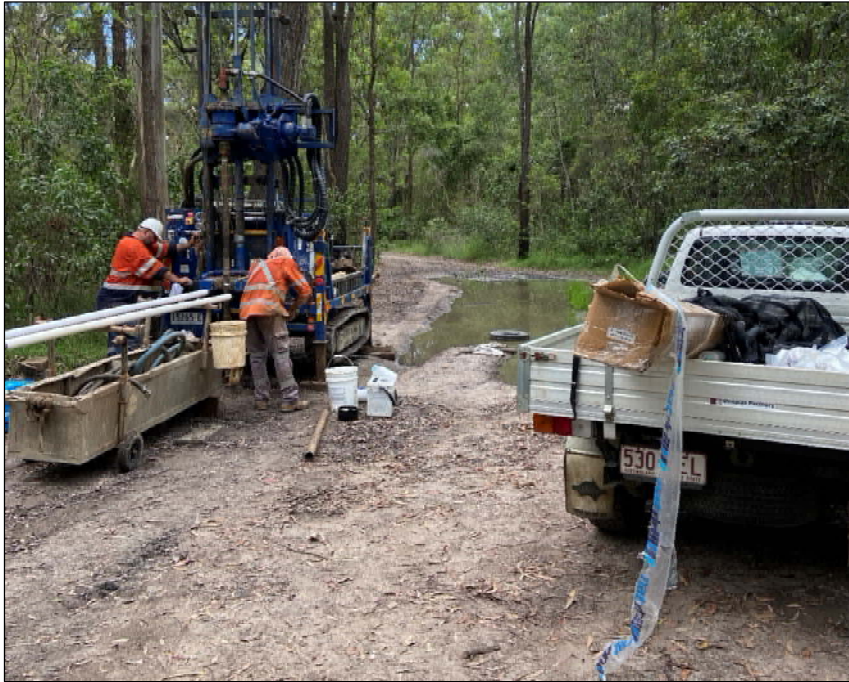
**Figure 1: Looking southwest towards Bore 8.**

Figure 1 and Figure 2 indicate typical site conditions encountered during the investigation.

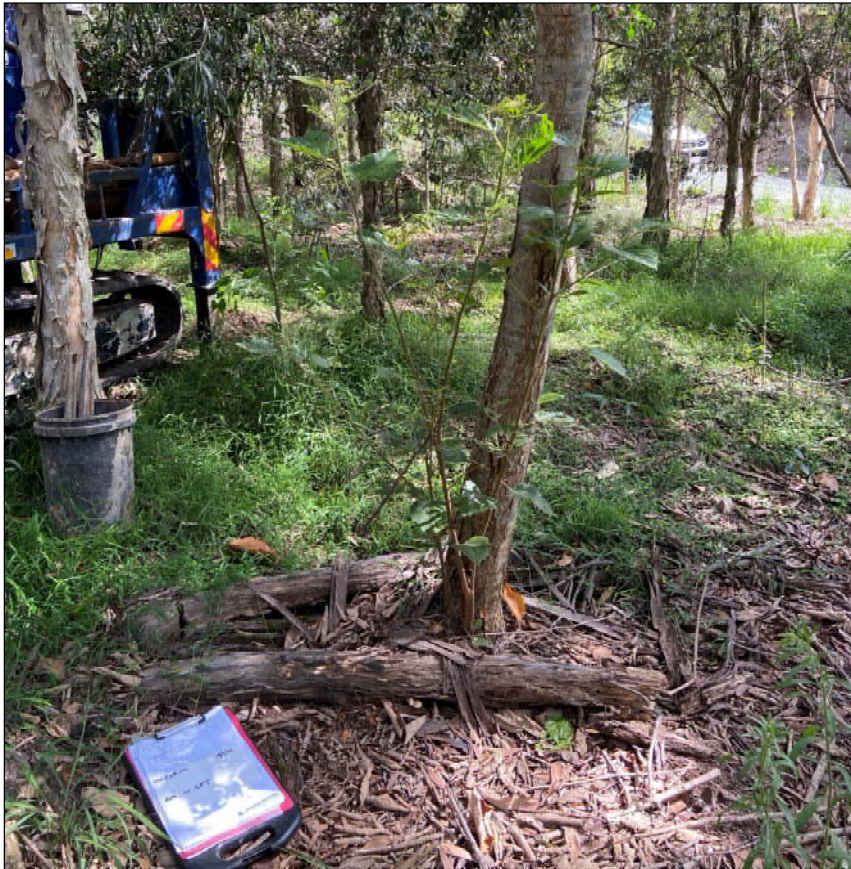
**Figure 2: Looking southwest from Bore 4.**

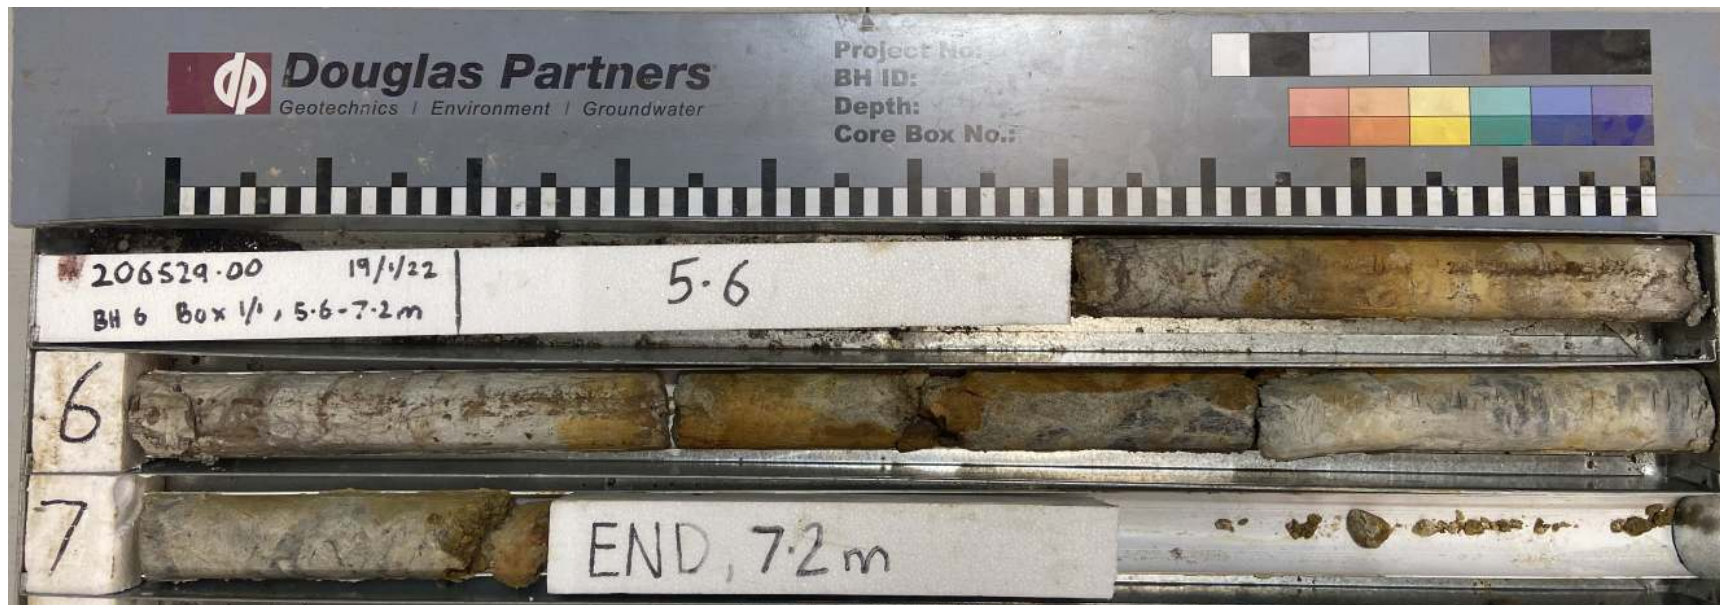
Bore: 6  
 Box: 1 of 1  
 Depth: 5.6 m to 7.2 m

**Core Photograph – Bore 6**  
**Proposed Trunk Gravity Sewer**  
**Christensen Road South, Stapylton**
