# REHABILITATION REPORT

82 Christensen Road, Stapylton

i<sup>3</sup> consulting was commissioned by Amgrow Pty Ltd to prepare reporting on the completed rehabilitation works for the site at 82 Christensen Road, Stapylton, on land described as Lot 500 on SP295994.

The purpose of this Rehabilitation Report is to demonstrate that remediation works have been completed on the lower proposed lease area of the site.

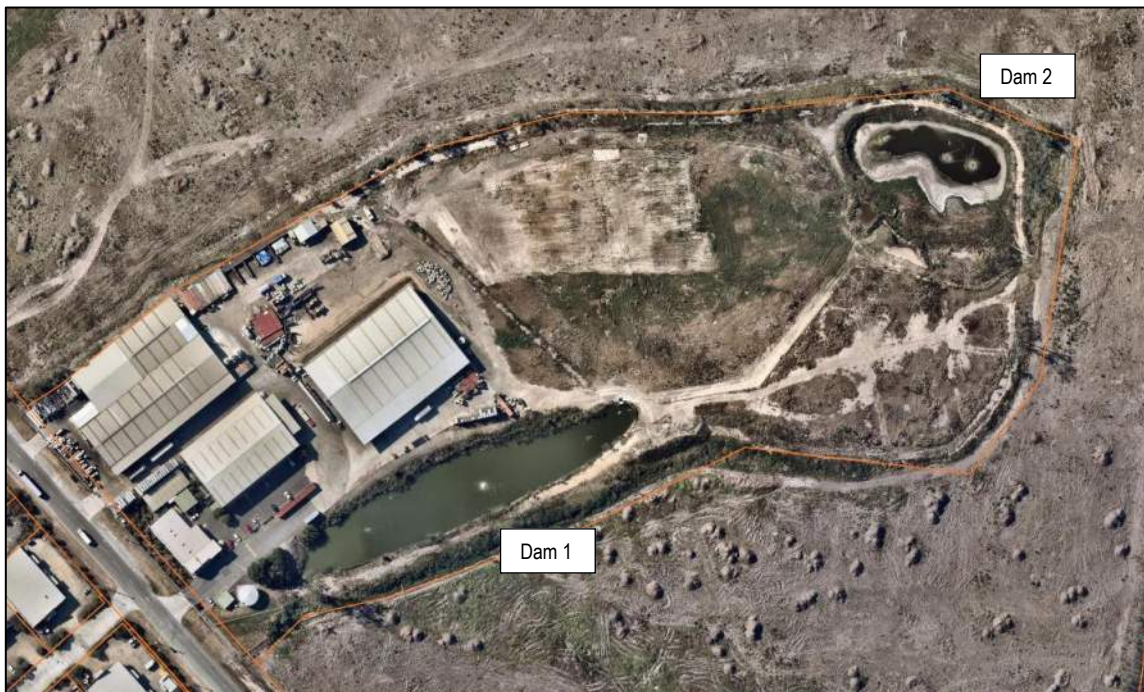
**Figure 2: Amgrow Site with location of Dams**

Figure 2 shows the site as of October 2019, including the locations of Dam 1 and Dam 2, while Figure 3 shows the site as of August 2020 and the completed rehabilitation works.

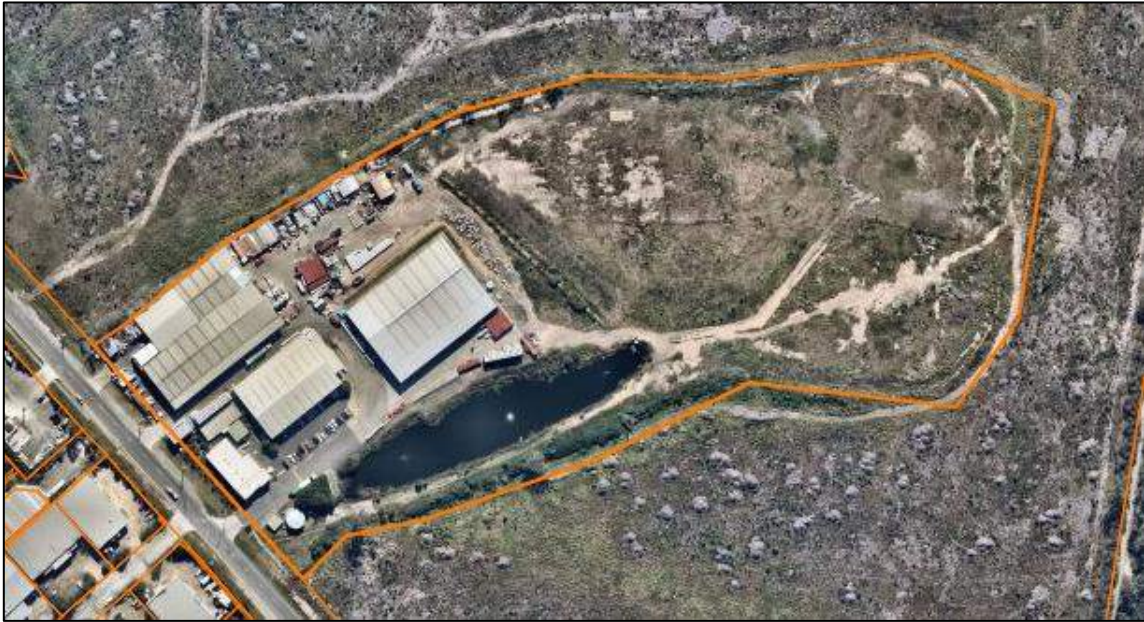
Figure 3: Amgrow Site with location of Dams

Based on the photographic evidence and imagery obtained from Nearmap, it can be seen that the former composting area and the sediment dam that serviced this area, Dam 2, have been successfully rehabilitated. The earthworks undertaken to fill in Dam 2, and the revegetation of the area have been undertaken in accordance with the rehabilitation goals for the eastern half of the site, and it has been returned to a condition that is suitable for surrender to the landowner.
