Re: Lot 334 SP193431, 84-160 Christensen Road South, STAPYLTON QLD 4207  
RESPONSE TO INFORMATION REQUEST,  
Council Ref: COM/2024/32  
ADG Ref: 27584 / C L001

HYDRANT DECOMMISSIONING PLAN

| Client<br><b>MULTI SPAN AUSTRALIA GROUP PTY LTD</b> | Discipline<br><b>CIVIL</b> | Status<br><b>APPROVAL</b> | Title<br><b>WATER PROPERTY CONNECTION LAYOUT PLAN AND DETAILS</b> |

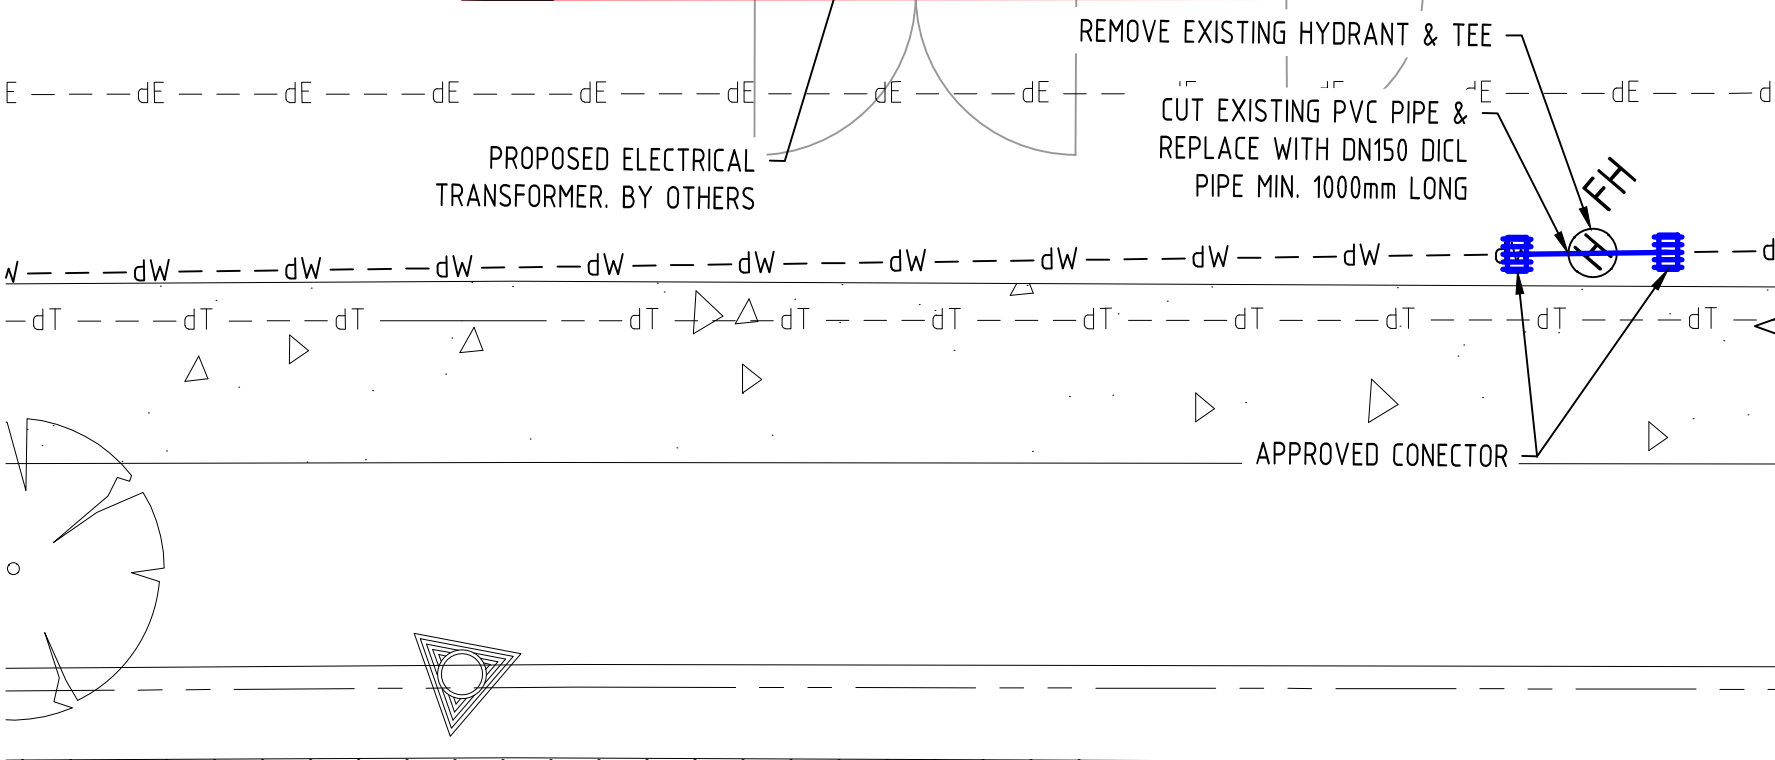
- CoGC OPERATIONAL WORKS APPROVAL REQUIRED FOR THESE WORKS
- 'APPLICATION TO WORK ON THE CITY'S INFRASTRUCTURE' APPROVAL REQUIRED FOR THESE WORKS.
- ALL LIVE WORKS TO BE COMPLETED UNDER SUPERVISION OF CoGC.

EXISTING SHOWN ARE BASED ON DETAILED SURVEY AND COUNCIL RECORDS. EXISTING SERVICES TO BE ACCURATELY LOCATED MINIMUM 10 DAYS PRIOR TO THE COMMENCEMENT OF WORKS AND INFORMATION SUPPLIED TO ADG ENGINEERS TO ENSURE THAT THE PROPOSED METER ARRANGEMENT CAN BE ACCOMMODATED AS SHOWN.

1. Noted. Material type changed to D1CL. Refer to Attachment A to this letter.
2. Item between valve and reducing tee is a DN100 blank flange, drilled and tapped to suit DN40 valve. Drawings updated to note as such.
3. The existing hydrant to be removed and replaced is due to the proximity to the proposed electrical transformer in accordance with AS2419.1:2021 S3.5.3.1, which requires a minimum distance of 10m from any transformer.
4. The proposed location ensures no loss of fire coverage in accordance with SEQ code.
5. Noted. Existing hydrant tee to be removed and replaced with pipe. This is shown on the revised plan - refer to Attachment A to this letter.

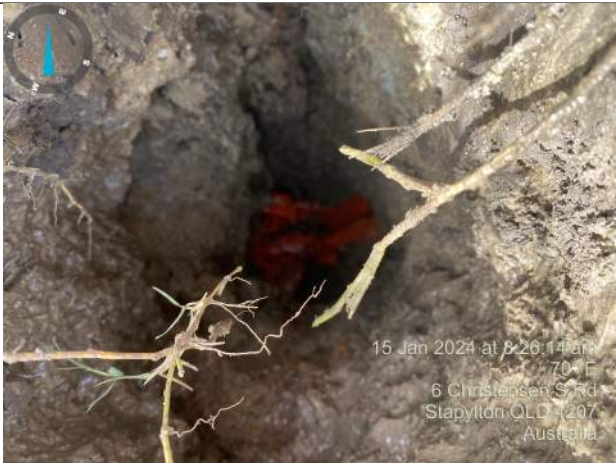
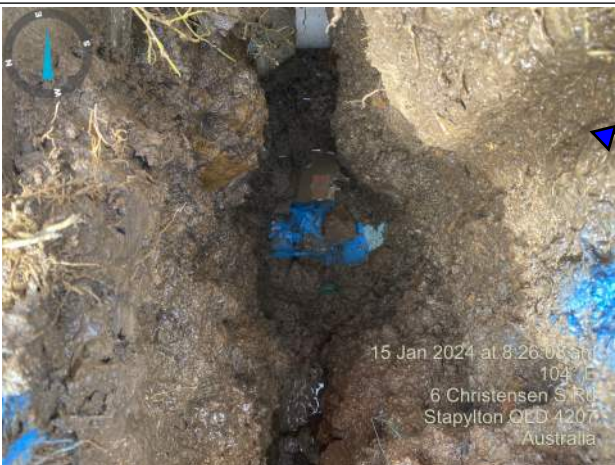
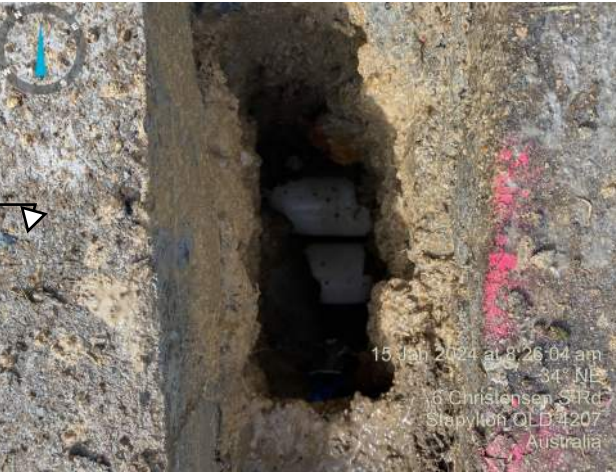
Photo 4 Location: Trench 1

| LEGEND:<br>0.9d = 0.9 meters depth<br>0.9 Inv = 0.9 meters to invert<br>0.9 TOP = 0.9 meters to top of pipe/cover to pipe | | GENERAL NOTES: | |

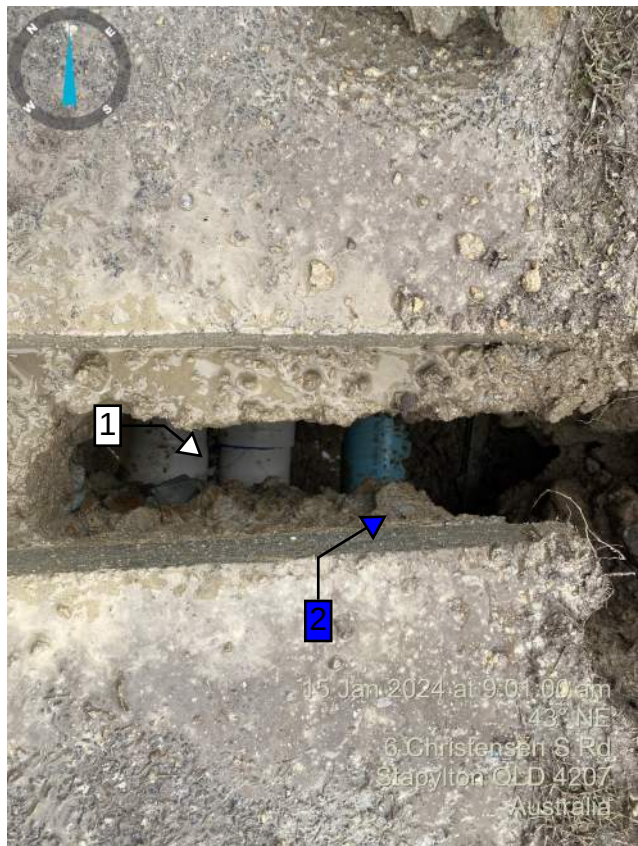
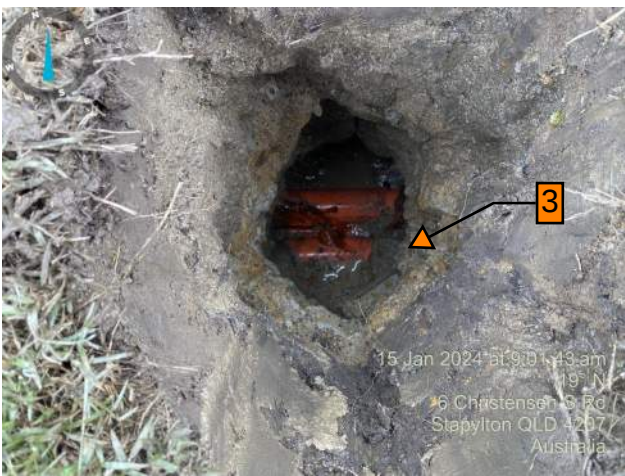
Photo 5 Location: Trench 2

| <b>LEGEND:</b><br>0.9d = 0.9 meters depth                      EOT = End of Trace<br>0.9 Inv = 0.9 meters to invert              UTT = Unable to Trace<br>0.9 TOP = 0.9 meters to top of pipe/cover to pipe | | <b>GENERAL NOTES:</b> |

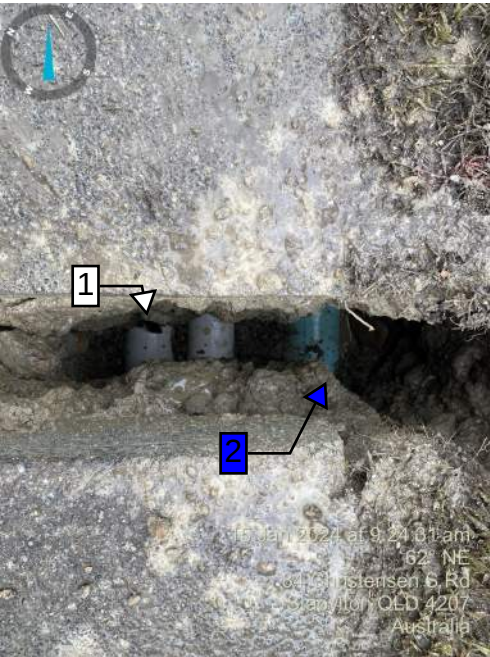
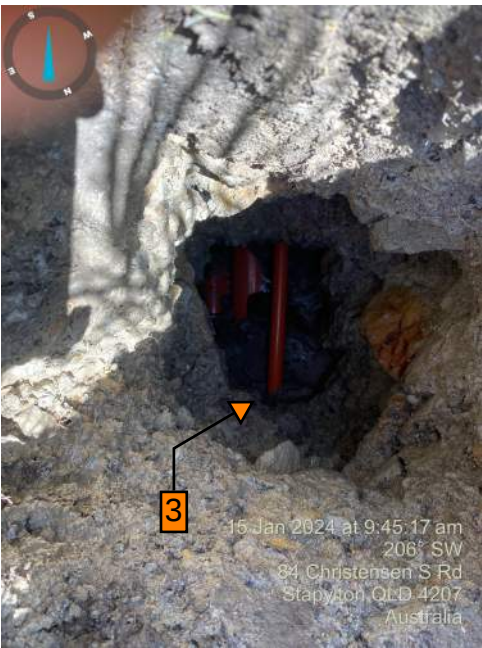
Photo 6 Location: Trench 3

| LEGEND:<br>0.9d = 0.9 meters depth<br>0.9 Inv = 0.9 meters to invert<br>0.9 TOP = 0.9 meters to top of pipe/cover to pipe | | GENERAL NOTES: | |
